Due Diligence Assessment Aboriginal Cultural Heritage

**Part of a
Site Re-development
for the Port of Echuca
Riverboat Access Ramp
Watson Street, Echuca
for
Murray River Council
and
Shire of Campaspe
June 2022**

Aboriginal Cultural Heritage Due Diligence Assessment Riverboat Ramp Watson Street, Echuca

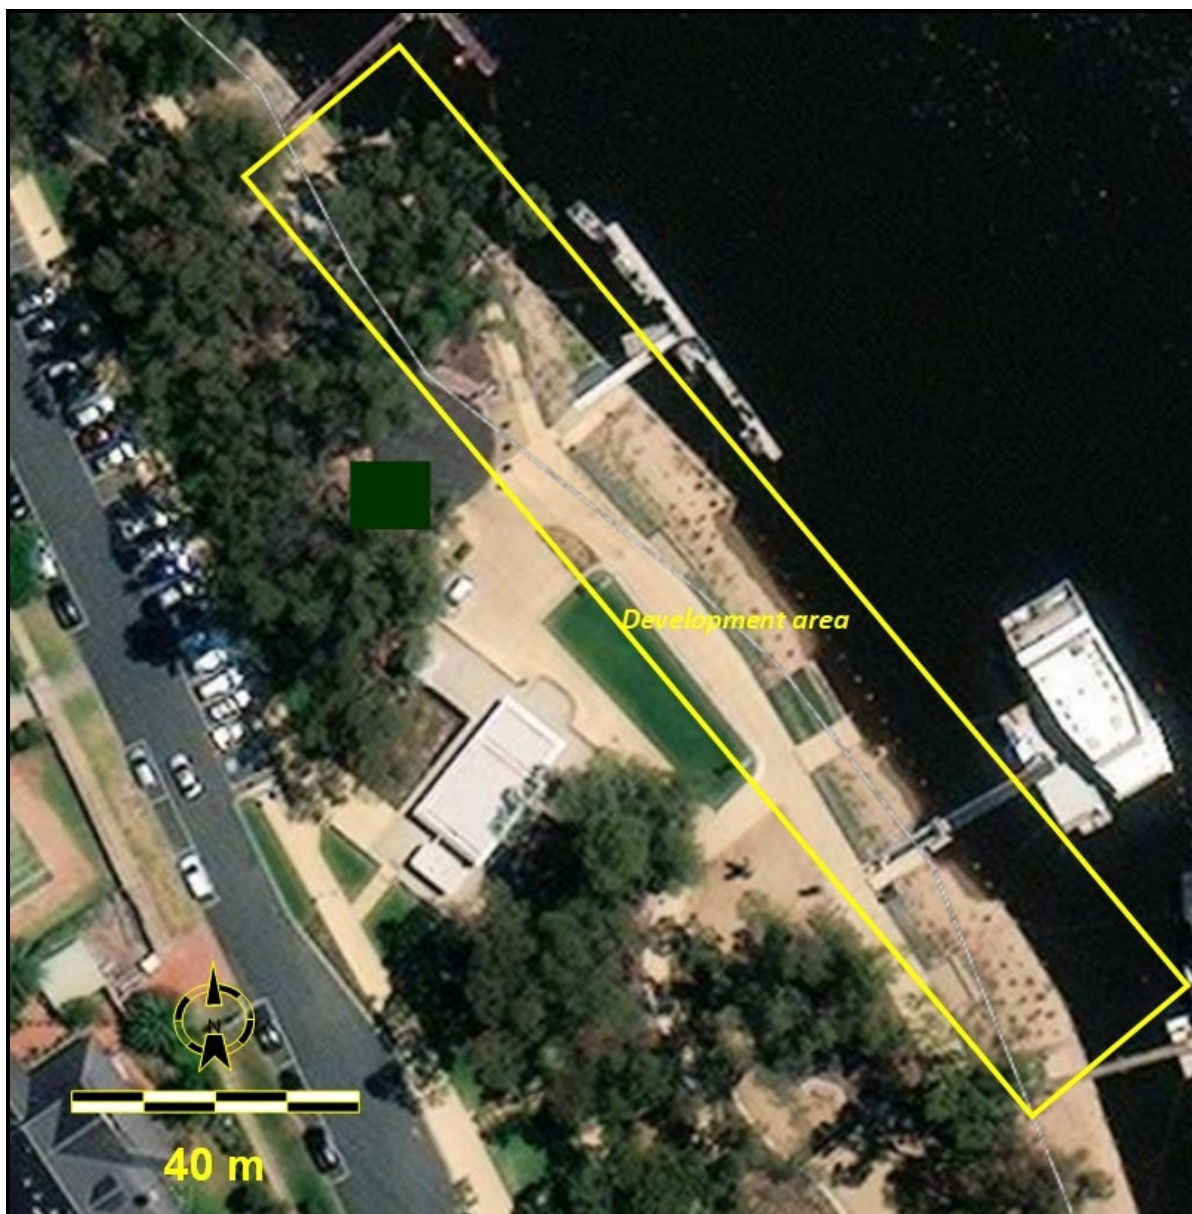
Figure 2. Site overview

The proposed development area and surrounding land was surveyed on foot along the existing banks and pathways (Figure 2). Within the survey area there has been considerable site disruption from small machinery

movement, high levels of foot traffic and pedestrian/vehicle access as well as construction of riverboat access infrastructure. Red gum (*Eucalyptus camaldulensis*) trees surrounding and within the development area for a distance of 100 m were inspected. Aerial photography was assessed for any patterns or signs of historical evidence of occupation or site activities relating to Aboriginal heritage.

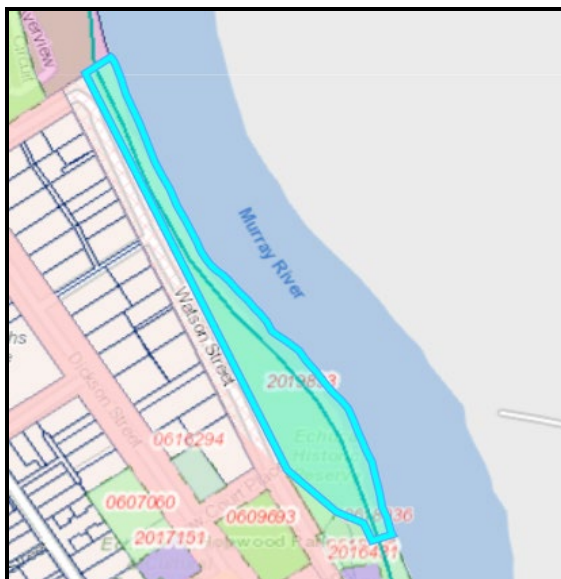
Figure 4. Victorian Crown Land allotment 2084 (Blue boundary) at the study site

There is no NSW DP or lot number assigned to the NSW land on the Victorian side of the Murray River. The Victorian Crown Land covering the site is: Allotment:2084; P number: P398900 Parish: Echuca North (Figure 4).

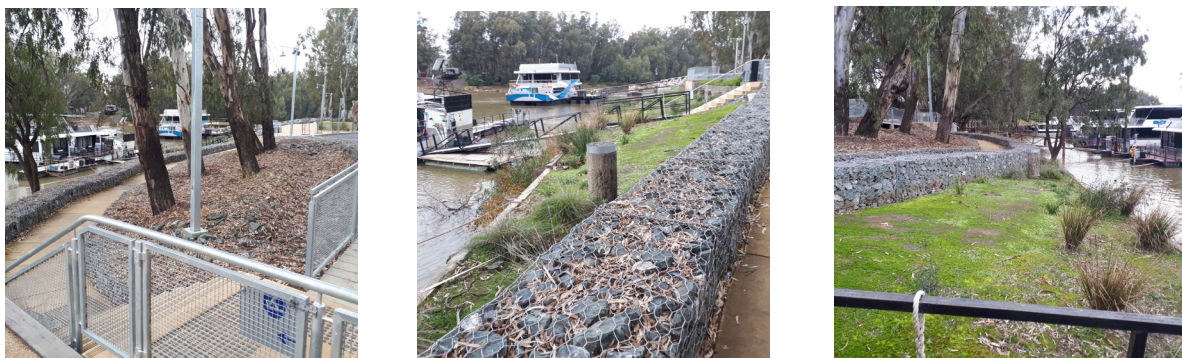
Figure 5. Main walkway development area - views east (2) and west (1)

The site topography of the proposed development area is steeply sloping (12%) river bank with a northerly aspect.

With regard to the third Objective, the steep vertical bank (>2 m height) necessitates the use of retaining walls in order to stabilise the site and prevent streambank erosion.

In reference to the final objective of the DCP (Landscaping) the access ramp construction will not impact the existing landscape aspects as it is mostly a remodelling of the existing path and retaining walls. The walls that are already in place and the small section that will be installed (Figure 3) will have a positive effect on the river system, by reducing accelerated bank erosion, re-establishing the native vegetation and importantly for aquatic fauna, preventing the degradation of water quality.

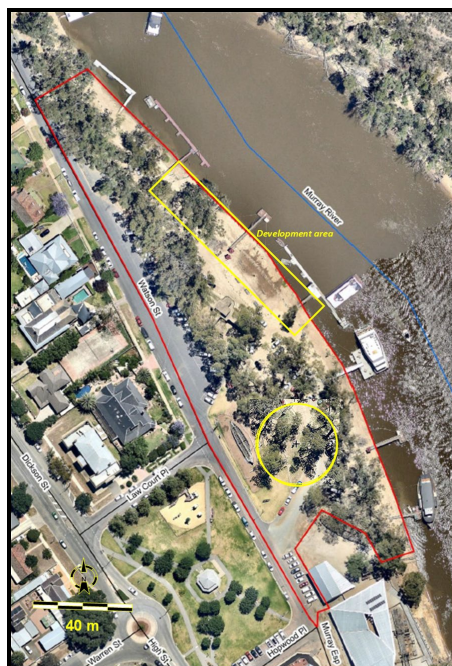
Figure 7. Scar tree location (Yellow circle) on the Victorian side of the border

Rhodes (2018) indicated that there is one scar tree site on the Victorian side of the river approximately 50 m south east of the development area (Figure 7).

Although not mentioned in the MLALC Report the presence of the scar tree (VAHR 78250-0506), which is outside the current development activity area should be noted.
