# Proposed Echuca Riverfront Development

## Historic Archaeological Assessment

**Final Report for the Shire of Campaspe**

**21<sup>st</sup> March 2018**

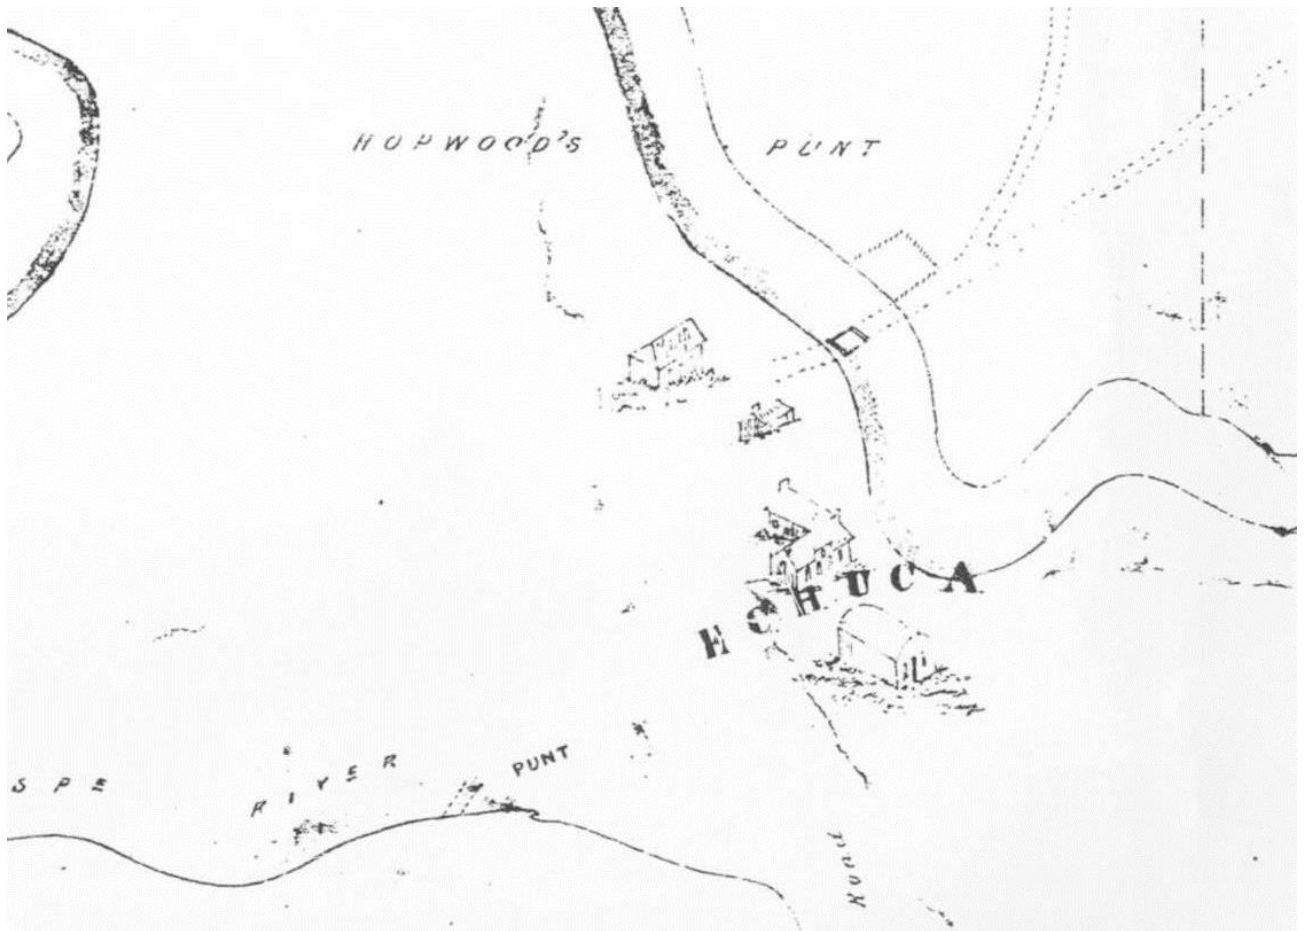
Figure 1: 1857 map showing the location of Hopwood's punt, the tollhouse/morgue and the second punt across the Campaspe River (Echuca Historical Society)

The location of Hopwood's original punt, hotel and associated buildings are shown on two early maps of Echuca, one dating from 1855 and the second dating from 1857 (Figure 1 and Map 6). The landing sites of the punt and pontoon bridge were situated in the south of the study area, adjoining what is now the Echuca Wharf Precinct. It has been possible to georeference the 1855 map using allotment and street boundaries to show the approximate location of Hopwood's punt (Map 6). On this map, it can be seen that there is a bend in the Murray River, which carried the river further east of the study area at this point. The 1855 map places the punt some 28m north-east of the existing river bank; the track leading from the punt to the embankment also appears to be depicted in a cut into the riverbank. This track also seems to be situated slightly south of the present access road to the carpark, but slightly north of the Echuca Wharf precinct. The higher embankment shown on the map (marking the edge of the Shepparton Formation) is in the same position as at present.

The track from Hopwood's punt led to a second crossing of the Campaspe River and then onto present-day Warren Street, as can be seen in Figure 1.

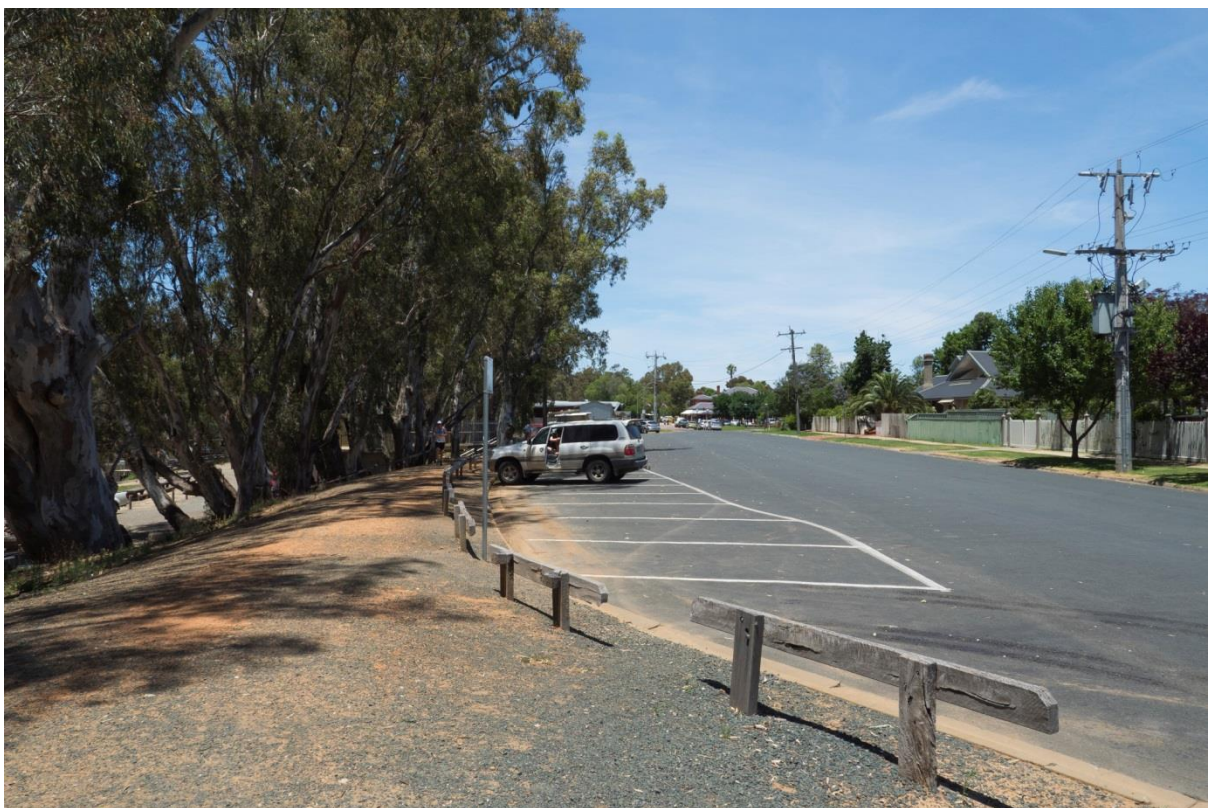
**Plate 2: Study area facing south along the crest of the natural embankment and Watson Street**

The study area is situated on the west bank of the Murray River and is made up of a higher embankment on the western boundary and a lower flat adjacent to the river. The embankment is the edge of the Shepparton Formation (see Map 4 and Plate 2), which comprises Pleistocene floodplain deposits of clay, sand, silt and gravel (Geological Survey of Victoria, 2001). The alluvial flat is part of the present floodplain of the Murray River, formed on Quaternary Alluvium (Geological Survey of Victoria 2001, see Map 5 and Plates 5-6). The alluvial soils have a shallow A Horizon that is a grey-brown loam, brownish-grey light clay with brown, brownish grey or dark grey clay B Horizon (Skene & Harford 1964: 24, 30). The upper 20cm of surface soil is usually well structured, but there are variants with a more poorly structured surface soil (Skene & Harford, 1964: 30).

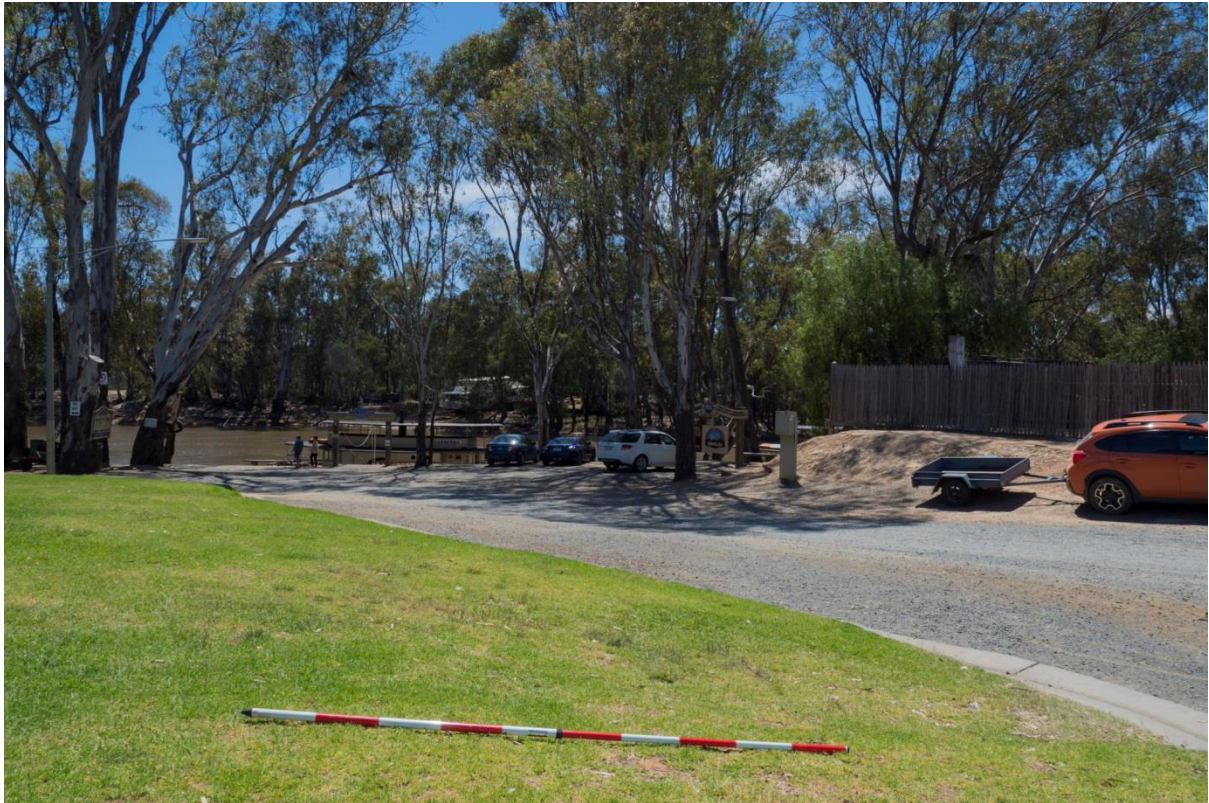
Plate 3: Alignment of proposed new access road at the south end of the study area, facing east.

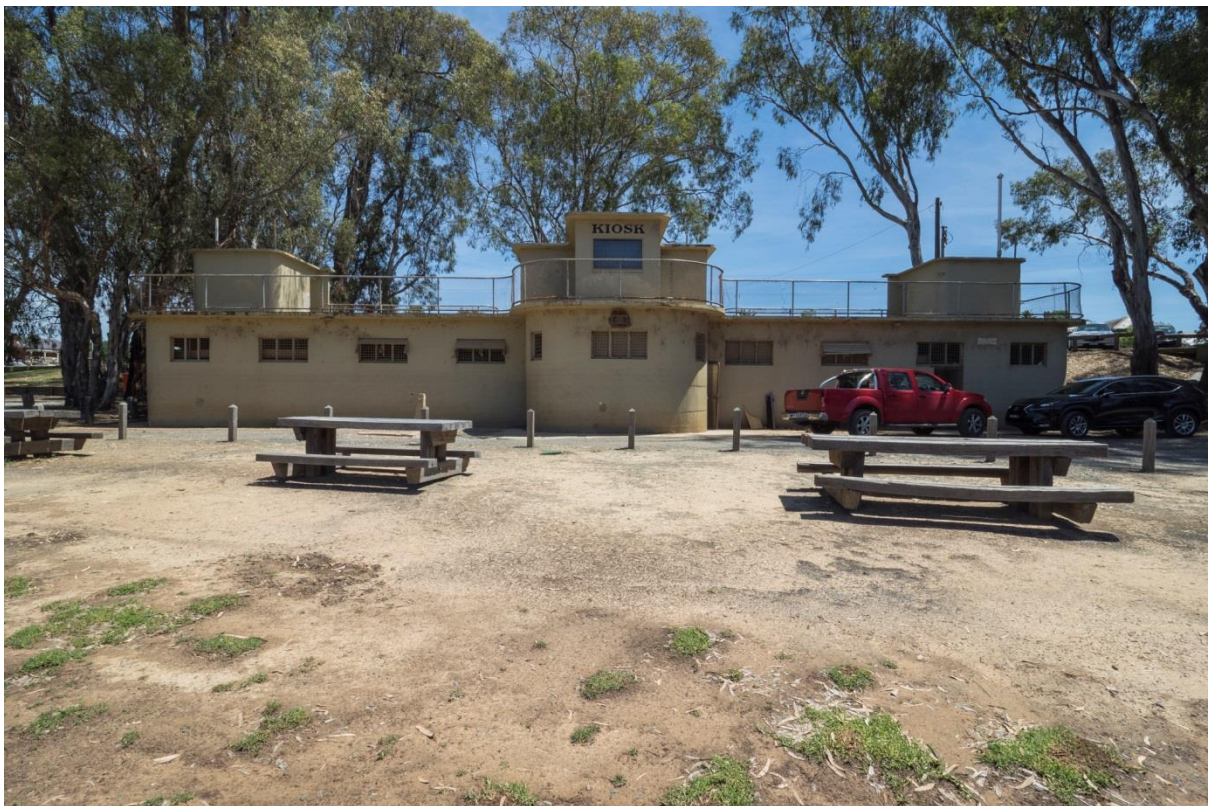
Plate 4: Concrete pavilion, containing changing rooms and kiosk facing west.

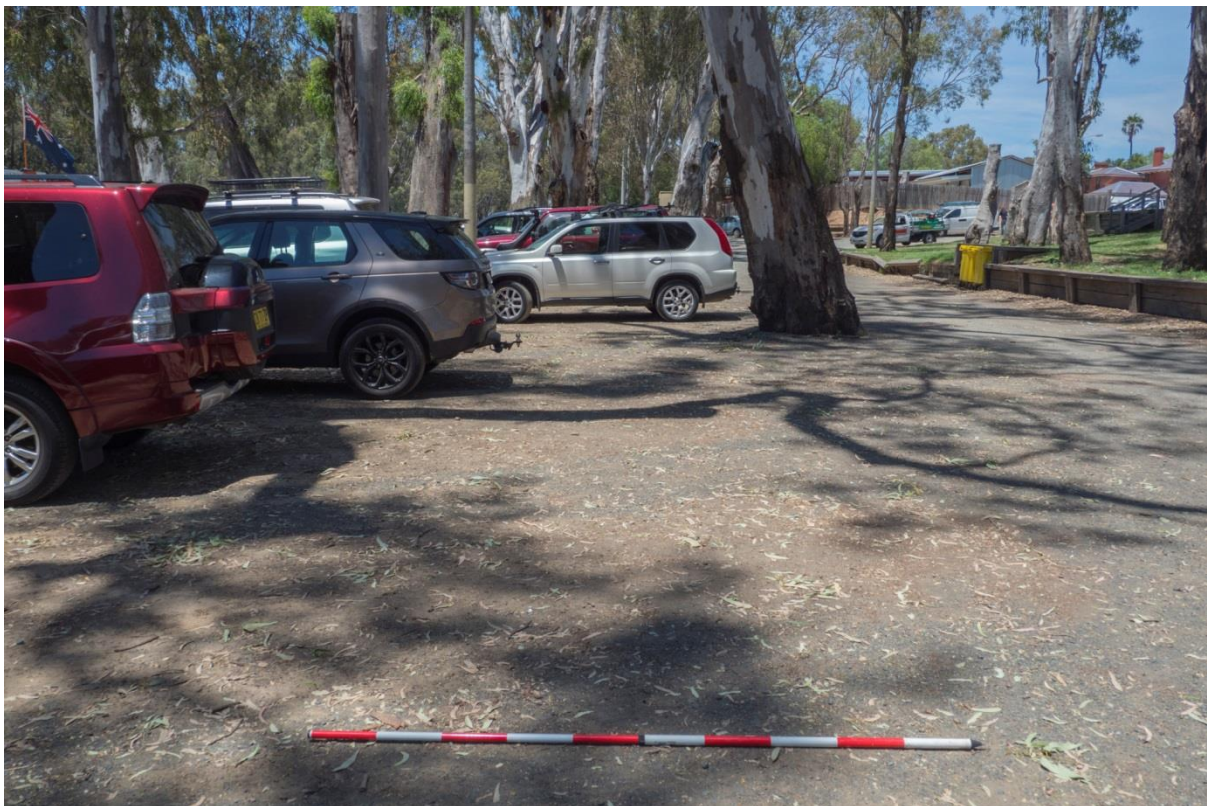
It is evident that the lower alluvial flat has been levelled, probably within the past c. 40 years, by the introduction of fill across the land surface. Soil levels around the base of mature red gum trunks have been increased, providing some evidence of this (Plate 6). As noted earlier, the geotechnical report states that there is some 25 - 30 cm of fill across the lower terrace. It is possible that the fill could mask any underlying historical features, but this is also considered unlikely. One of the main features that may exist are the concrete steps leading to the former pontoon, if they were not removed.

Plate 6: Looking south along the existing car park on the alluvial plain. Note the height of fill against the red gum trunk in the background.

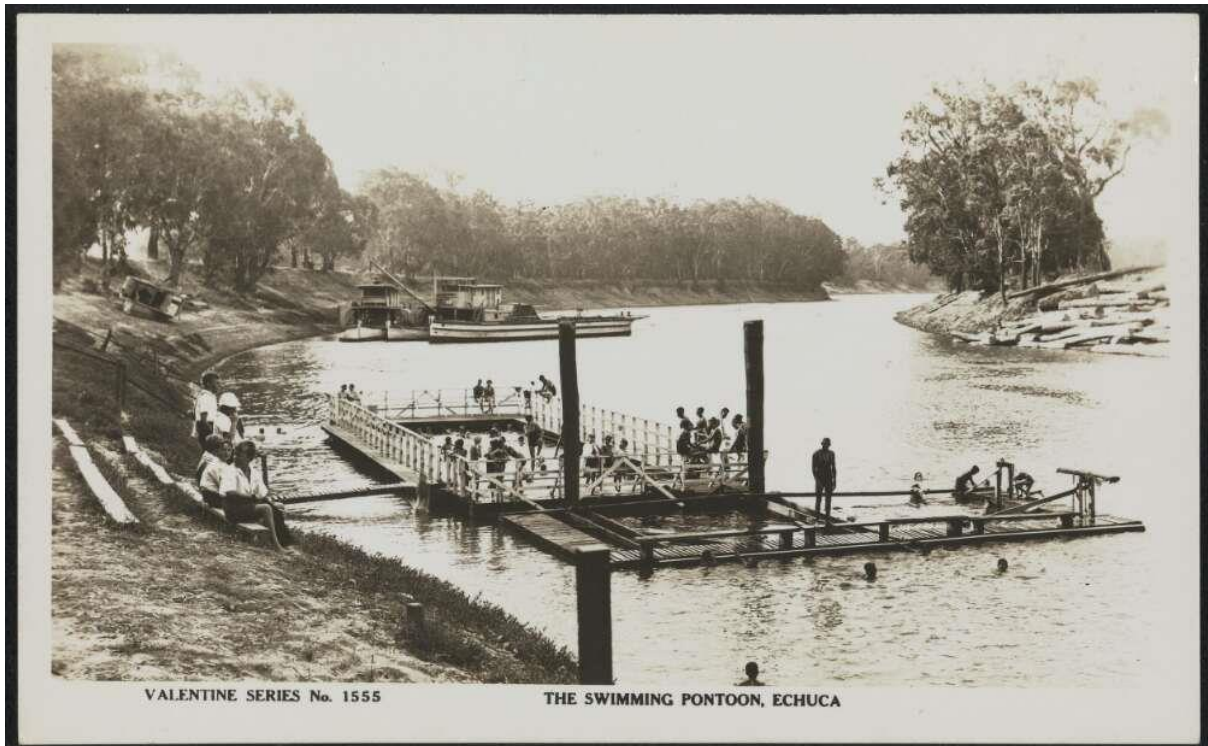
Plate 9: Postcard showing the swimming pontoon probably c. 1920's (National Library of Australia)

The only other significant structure in the study area is the concrete swimming pavilion. A swimming club was formed in Echuca during 1911 (Riverine Herald, 4<sup>th</sup> November 1911) and a newspaper article from 1912 refers to a fete and races held by the swimming club at the 'punt gangway' (Bendigo Independent, 1<sup>st</sup> March, 1912), which implies a location near Hopwood's punt. During 1926, a pontoon to act as a swimming enclosure was constructed at the slipway opposite (The Age, 15<sup>th</sup> November, 1926) and presumably towed into place at the north end of the study area. An early photo of the pontoon is shown in Plate 9. The image is dated to 1910, but this is possibly in error, since the pontoon shown in Plate 9 is the same structure as that shown in later images.

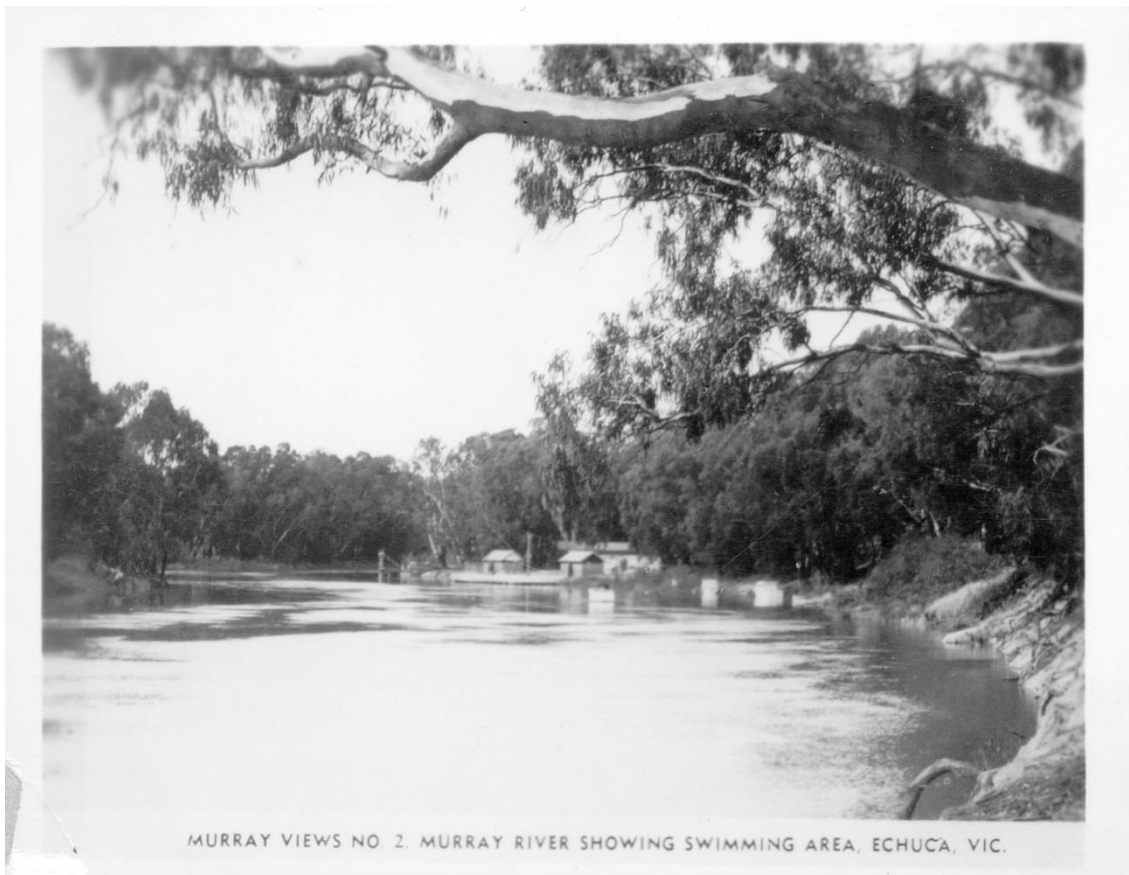
Plate 10: Postcard c.1945 looking south along the river bank towards the pontoon (State Library of Victoria)

A cottage at Torrumbarry was purchased by the Echuca Swimming Club for the use of a caretaker during 1927 (The Age, 2<sup>nd</sup> November, 1927). The intention was to move the cottage to a location near the pontoon. The cottage along with changing rooms, appear to have been erected on the river bank behind (west of) the pontoon. Both the cottage and change rooms are visible in a 1945 postcard showing a view along the riverbank, looking south towards the pontoon (Plate 10).

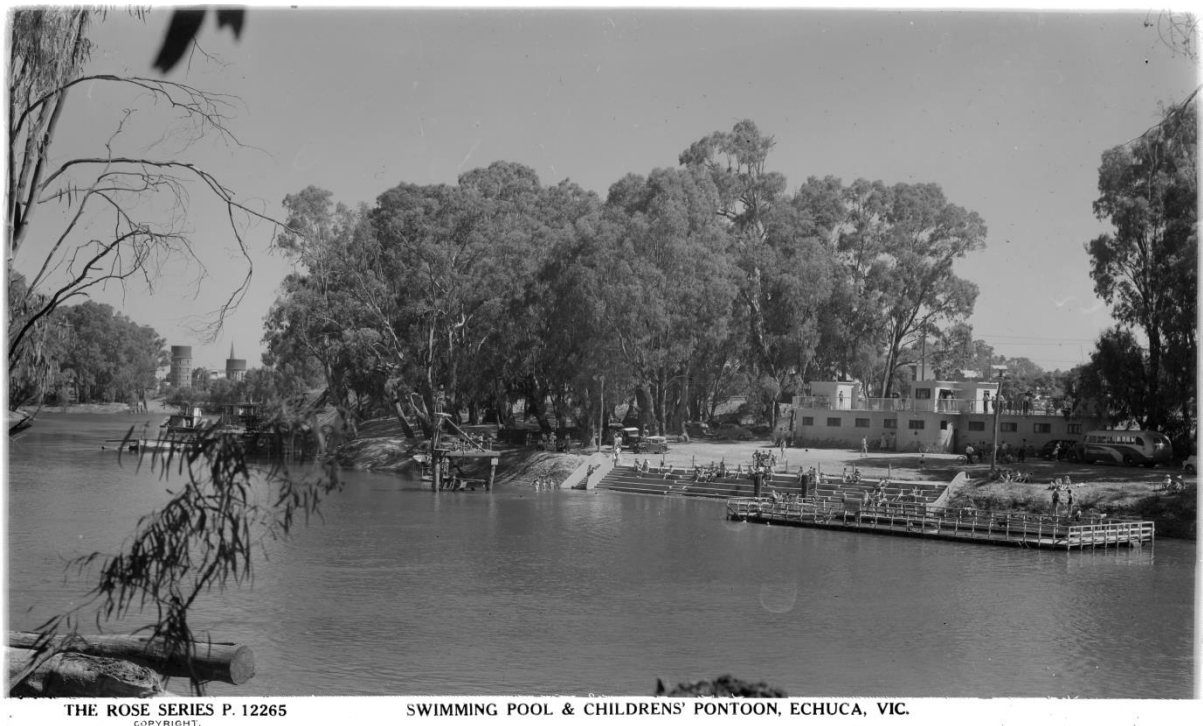
Only one other known historical feature was found within the study area. These were the pontoon baths and associated structures on the river bank. Originally there appear to have been two separate change rooms and a caretakers hut erected behind the pontoon. These were removed during the 1940's and replaced by the existing concrete pavilion. There were concrete stairs leading to the pontoon in front of the pavilion and on the river bank. These stairs have either been removed or covered over with fill behind timber sheeting on the river bank.

Plate 12: View looking south-west showing the pontoon, pavilion and concrete steps c. 1950 (State Library of Victoria)

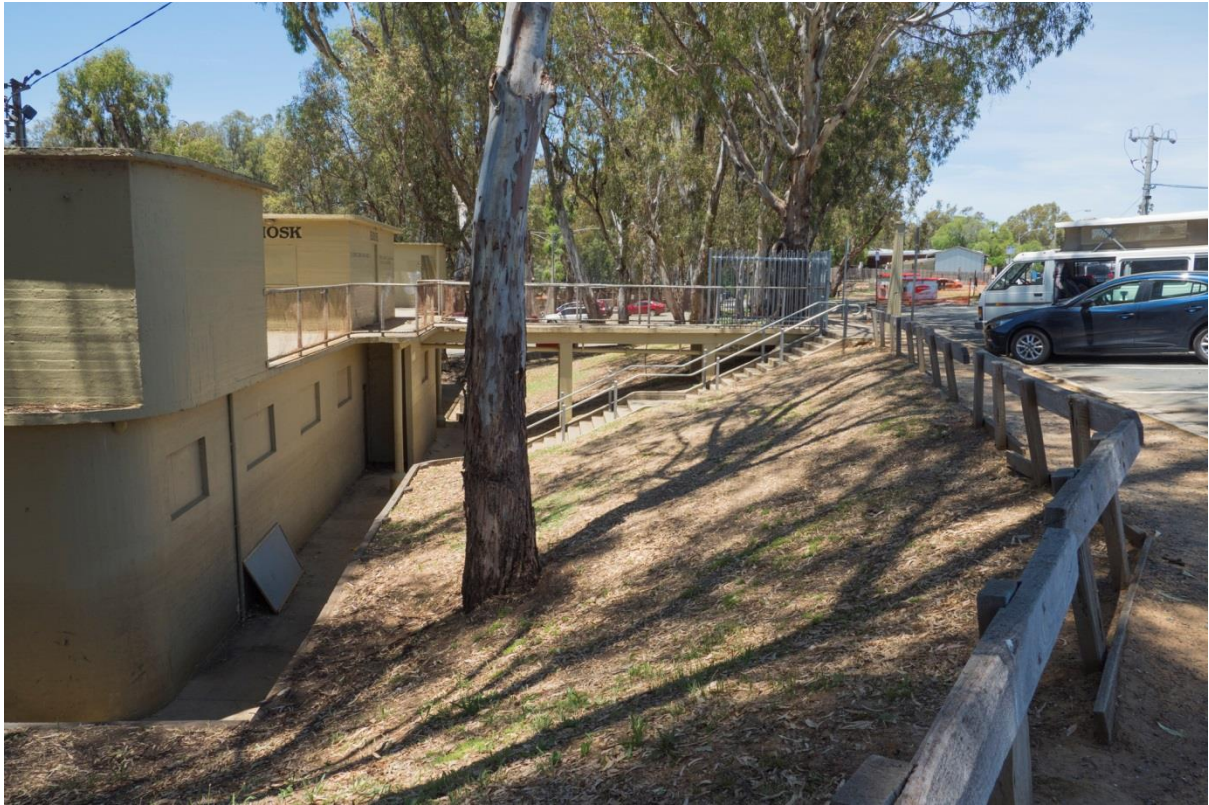
There is considerable ground disturbance across the study area. The slope behind (west of) the pavilion has been cut back to enable construction of the latter (Plate 13). It is likely that soil excavated during construction was also thrown back over the slope. The external walls and roof of the pavilion appear to be in good condition as is the rear access path leading to the top storey of the structure (Plates 4 and 13-14). Original concrete lamp posts flanking the entrance to the roof top pathway are in good condition (Plates 15 - 16) and will be retained and relocated during works for the modernisation of the new pavilion.

Plate 13: Rear wall of pavilion facing south.

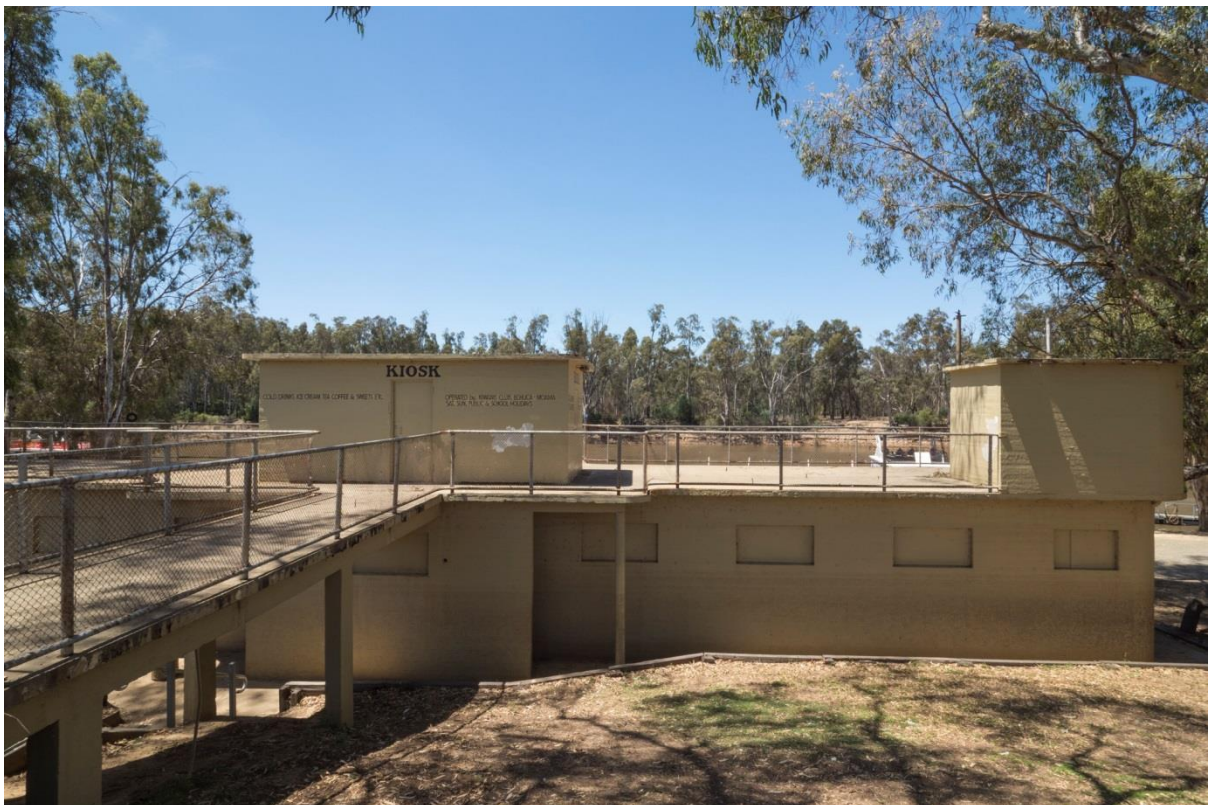
Plate 14: Southern half of pavilion building (rear) facing east.

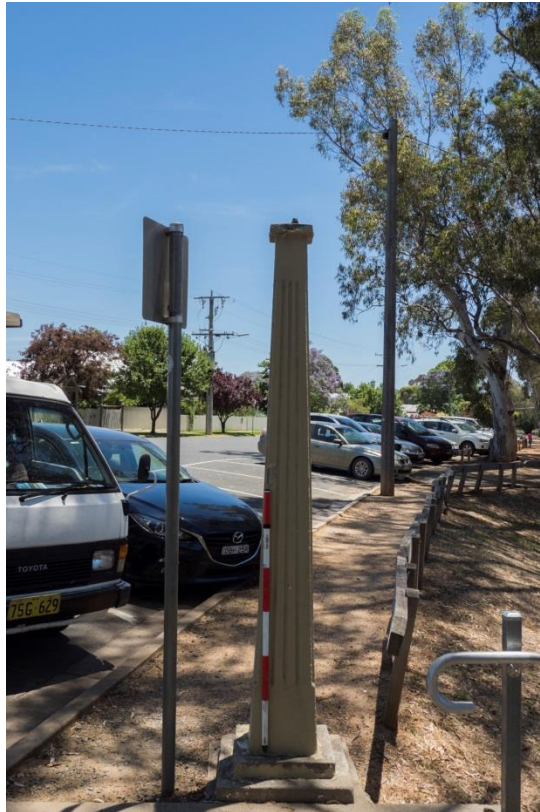
Plate 15: Concrete lamp post on the north side of pavilion entrance at Watson Street.

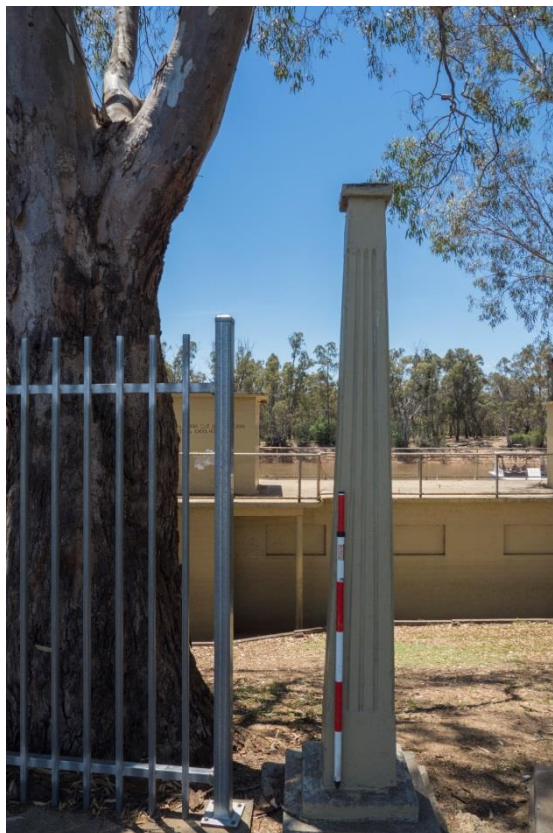
Plate 16: Concrete lamp post on the south side of pavilion entrance at Watson Street.

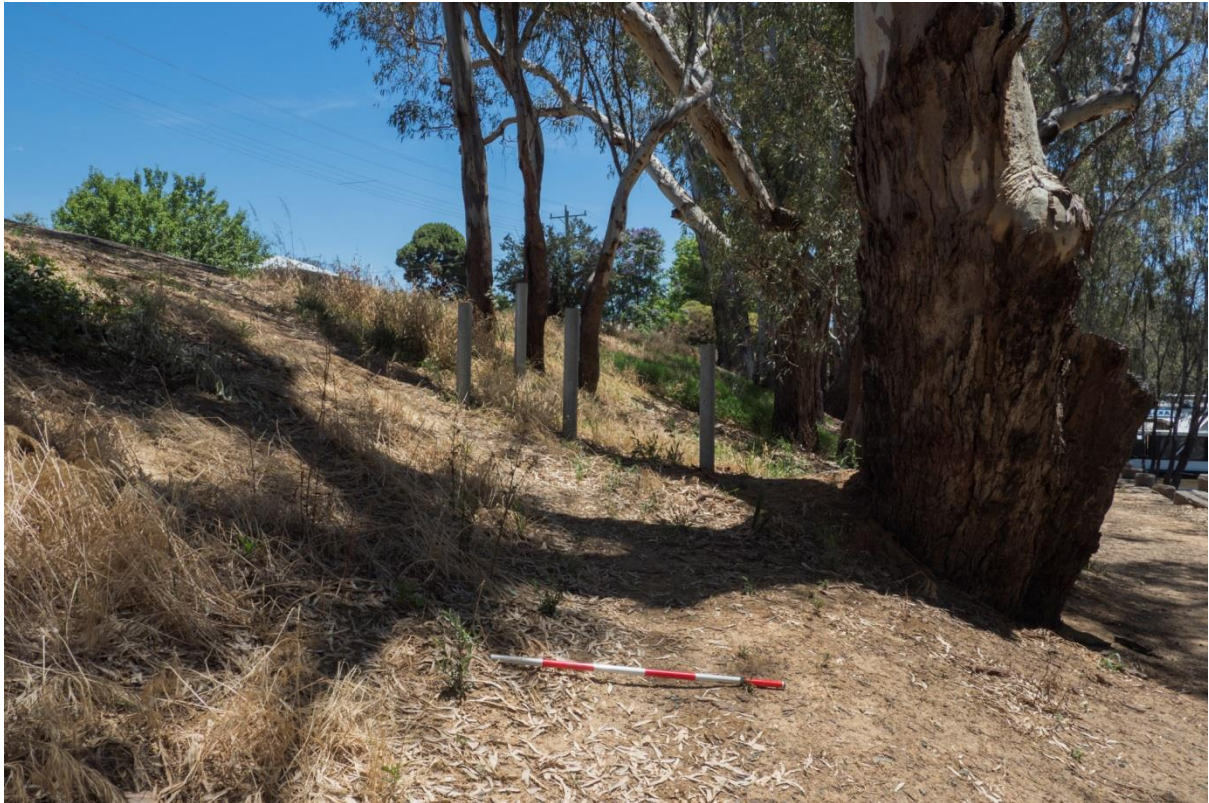
An existing informal walking track which will form the new entrance at the north end of the site, was also inspected closely. The walking track is north of the pavilion and crosses the bank and escarpment on the east side of Watson Street (Plate 17). No archaeological features were noted.

**Plate 17: Alignment of the new access road at the north end of the study area, facing north.**

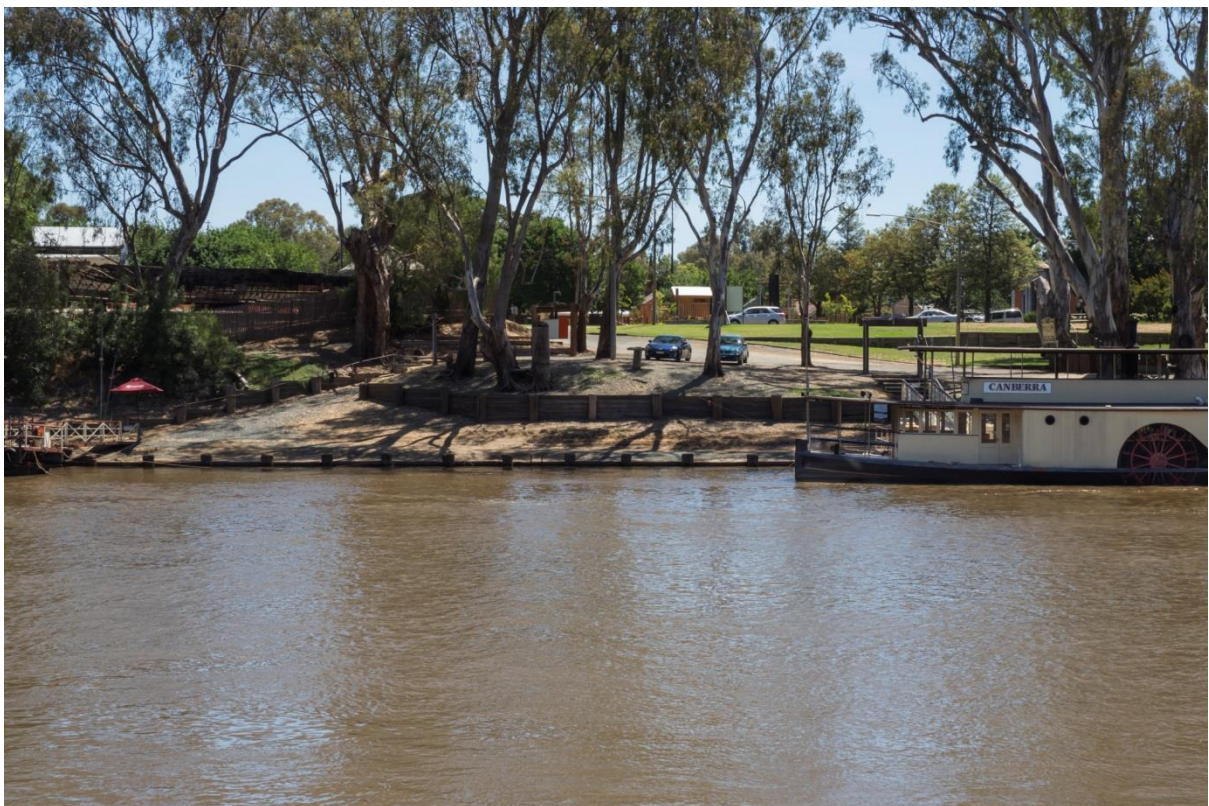
**Plate 18: General location of the tracks from Hopwood's punt and pontoon bridge, facing west.**

The probable alignments of the punt and pontoon tracks across the contemporary river bank are illustrated in Plate 18. The track from Hovell's punt likely crossed near the river bank near the current mooring for the paddle steamer Canberra, while the track from the pontoon bridge was further south and traversed the current Echuca Wharf Precinct. Both tracks likely ran along the east side of the existing visitor interpretation centre and to the site of the original Echuca Wharf. However, the wharf was not constructed until a slightly later date in the 1860's (Lovell, 2007). Along with the river trade, the use of the punt and pontoon bridge would have declined after construction of the cross-border railway bridge c. 1877 (Lovell, 2007).

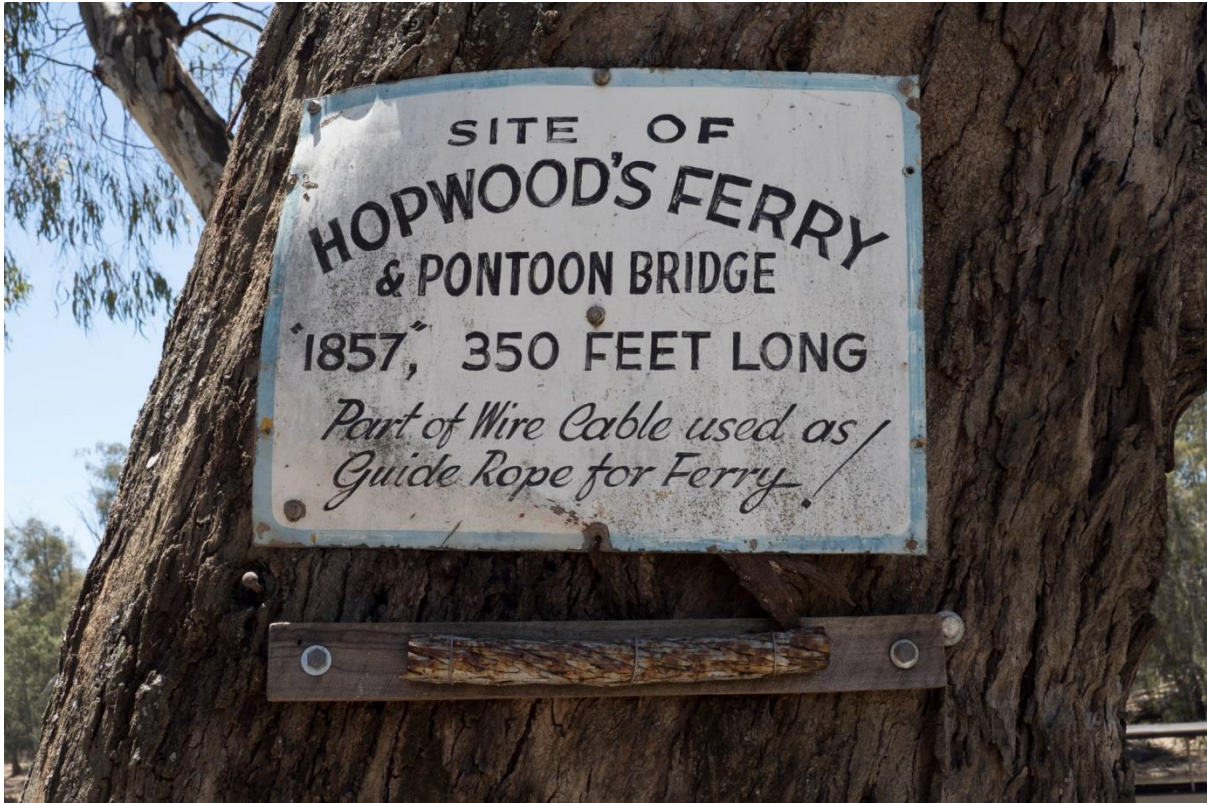
Plate 19: Historical interpretation sign with punt cable.

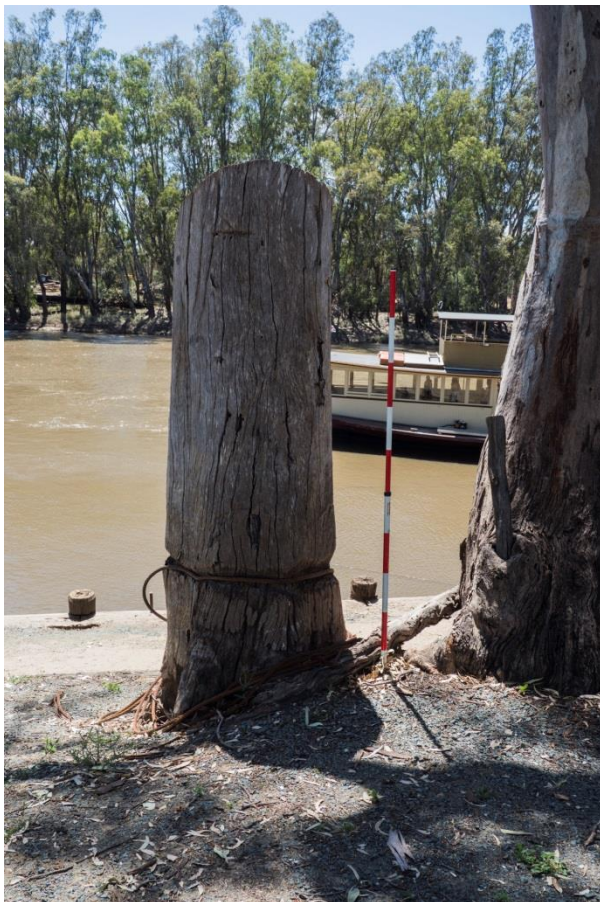
A dead stump of a mature eucalypt with a steel cable tie attached was found on the river bank at this location (Plate 20). It is more likely that the cable and tree trunk were used as a mooring for paddle steamers. The cable is more modern and a smaller diameter, than the example of the cable used for Hopwood's punt (see Plate 19). The mooring stump itself is some 40m west of the original river bank.

Plate 20: Stump with mooring cable on the east bank of the river
