Project:
Maudesley Pump Supply Relocation
Client:
Maudsley Pty Ltd
Address:
'Forest Gate'
Cobb Hwy Mathoura, NSW

PROPOSED IRRIGATION PUMP AND PIPELINE ON THE GULPA CREEK

Cultural Heritage Due Diligence Assessment

New pump site and pipeline on the Gulpa Creek and Cobb Hwy at
'Forest Gate', Gulpa NSW

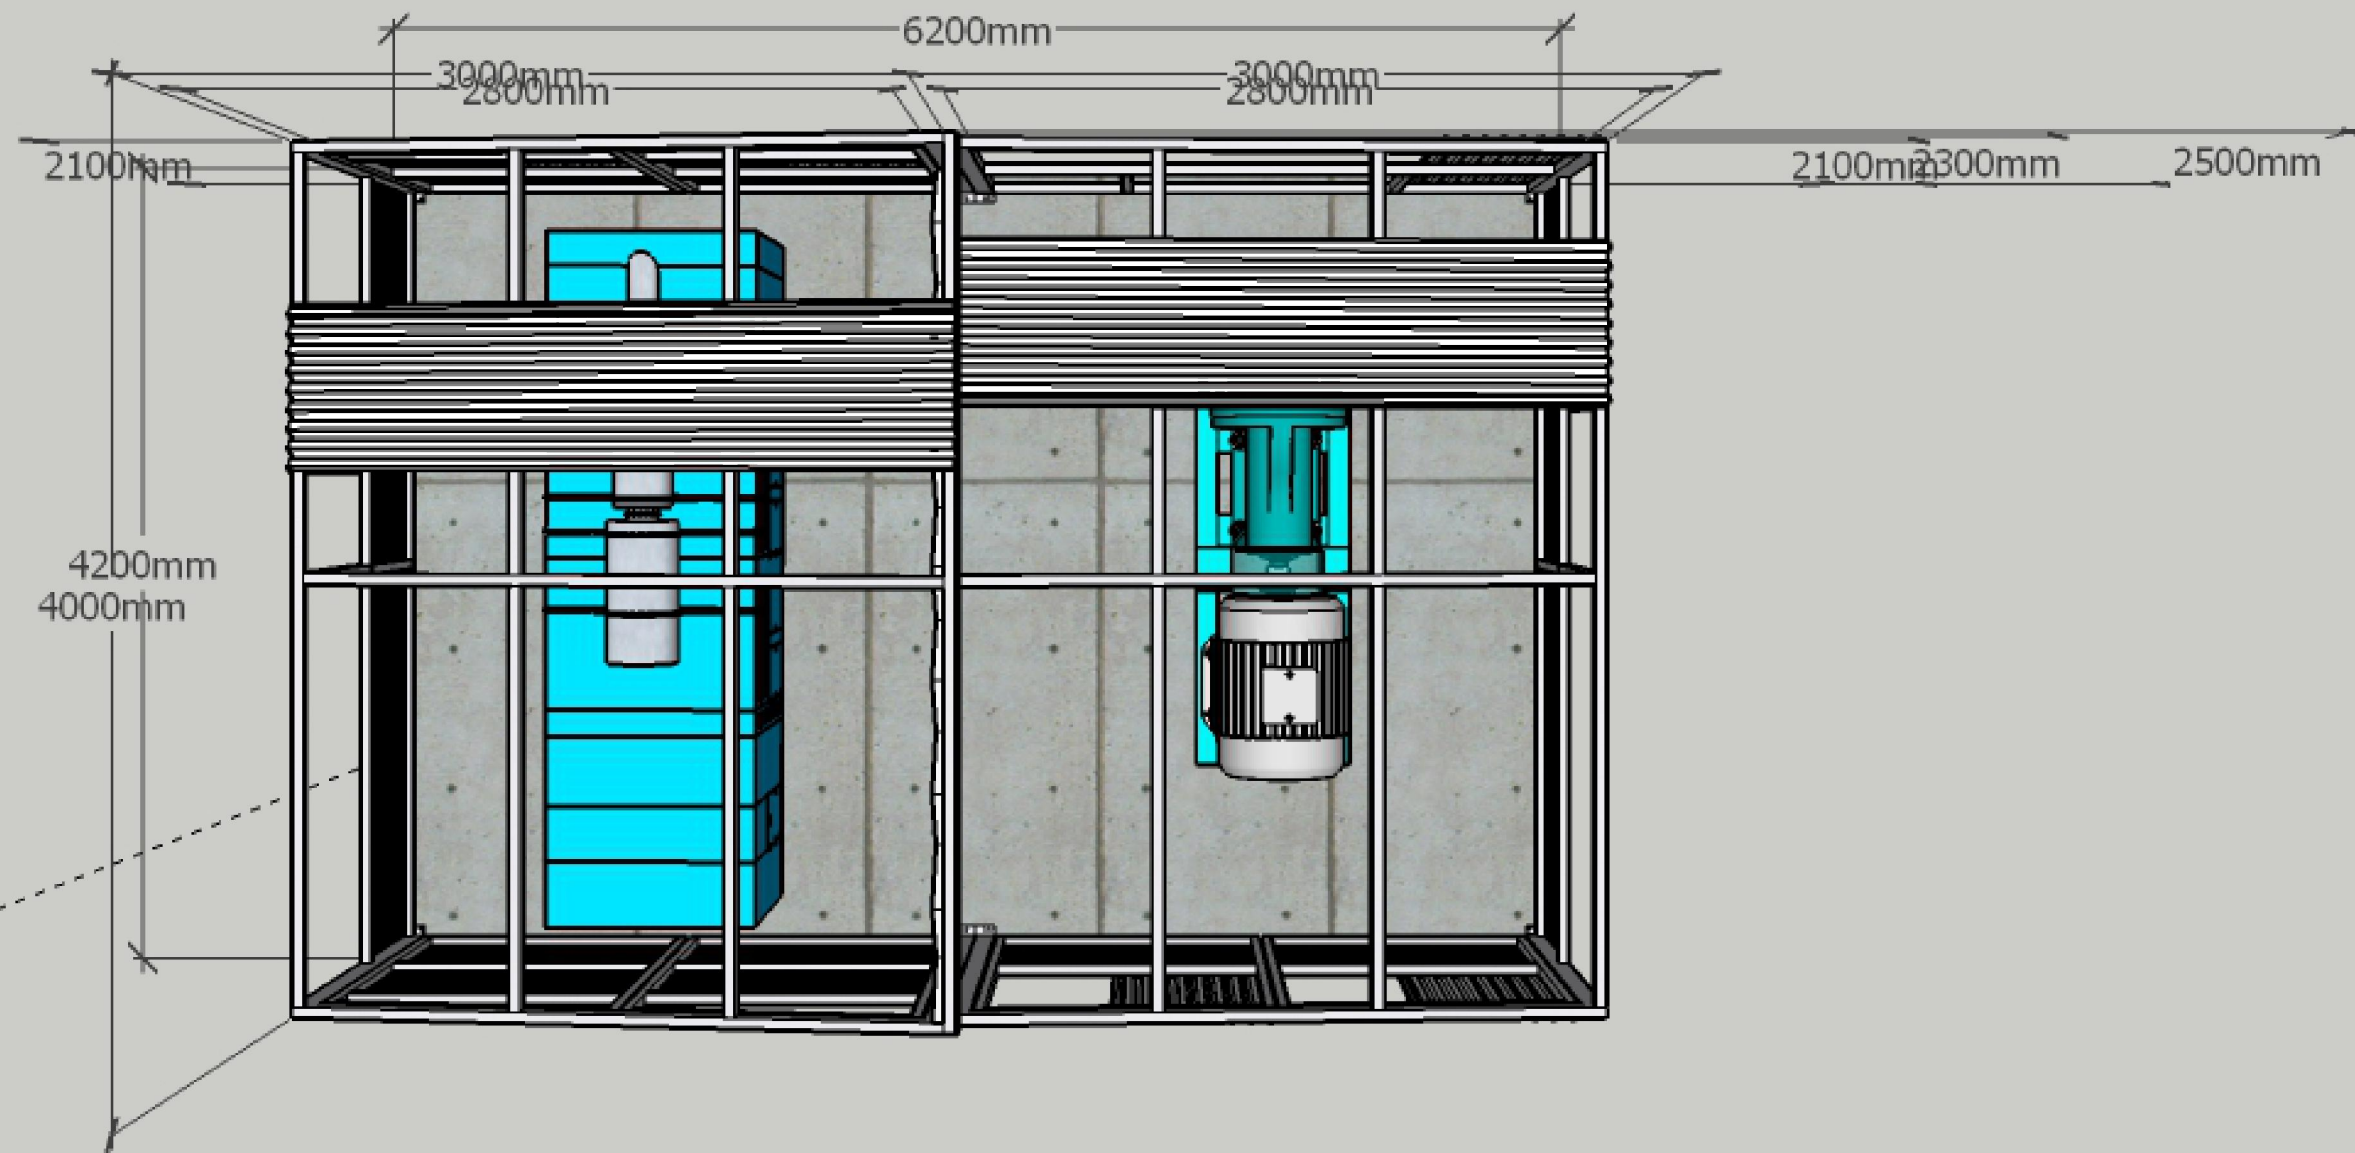
Comments:
Sheet 1 of 5
.
.

Date: 06/12/2022
Job No: QU-0785
Waterway: Gulpa Creek
Plan:
Shed showing pump
Plan View

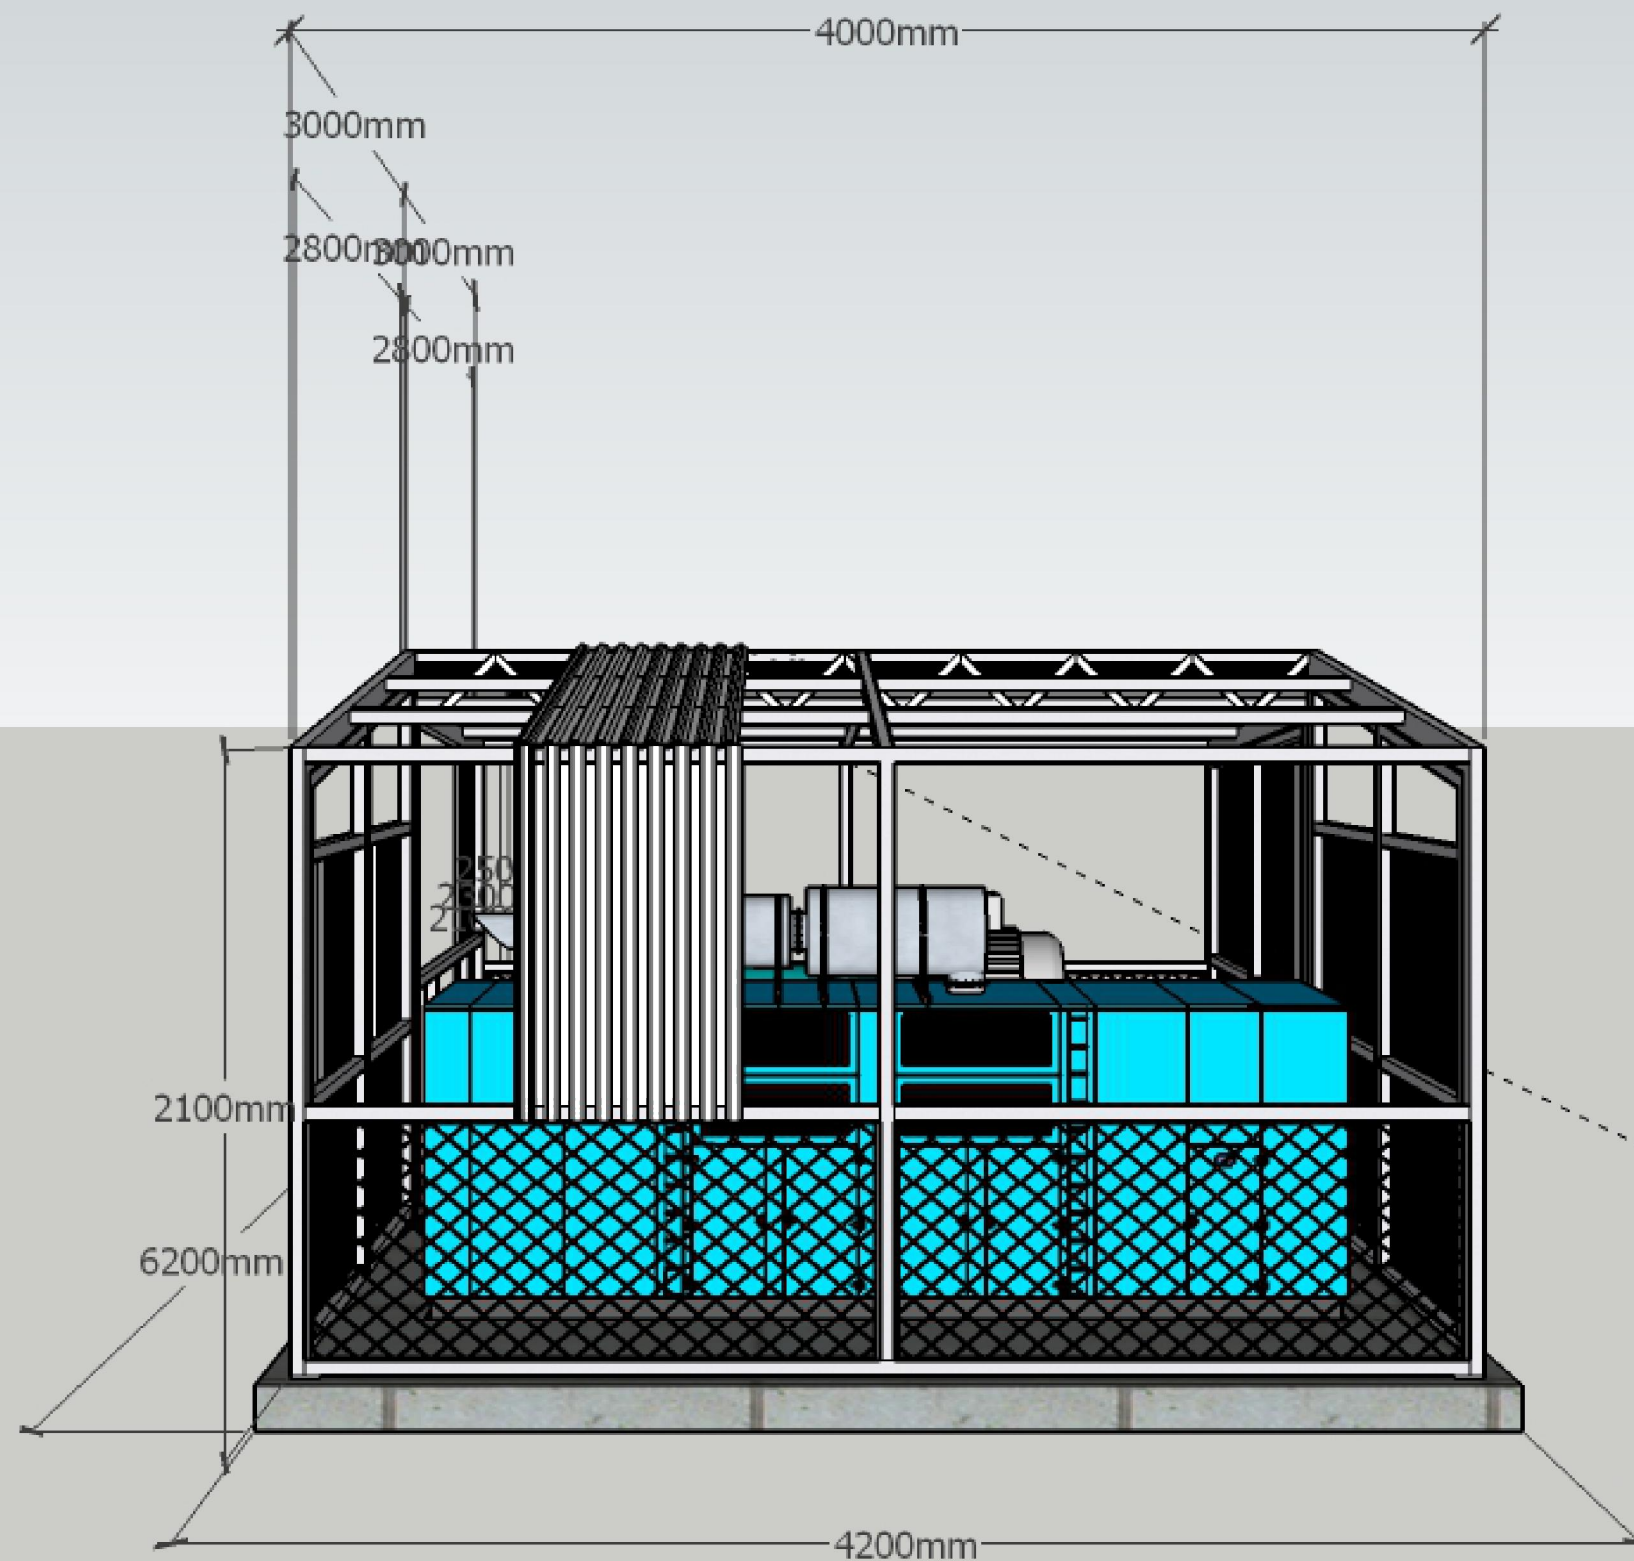
Comments:
Sheet 2 of 5
.
.

Plan:
Shed showing pump
West Elevation

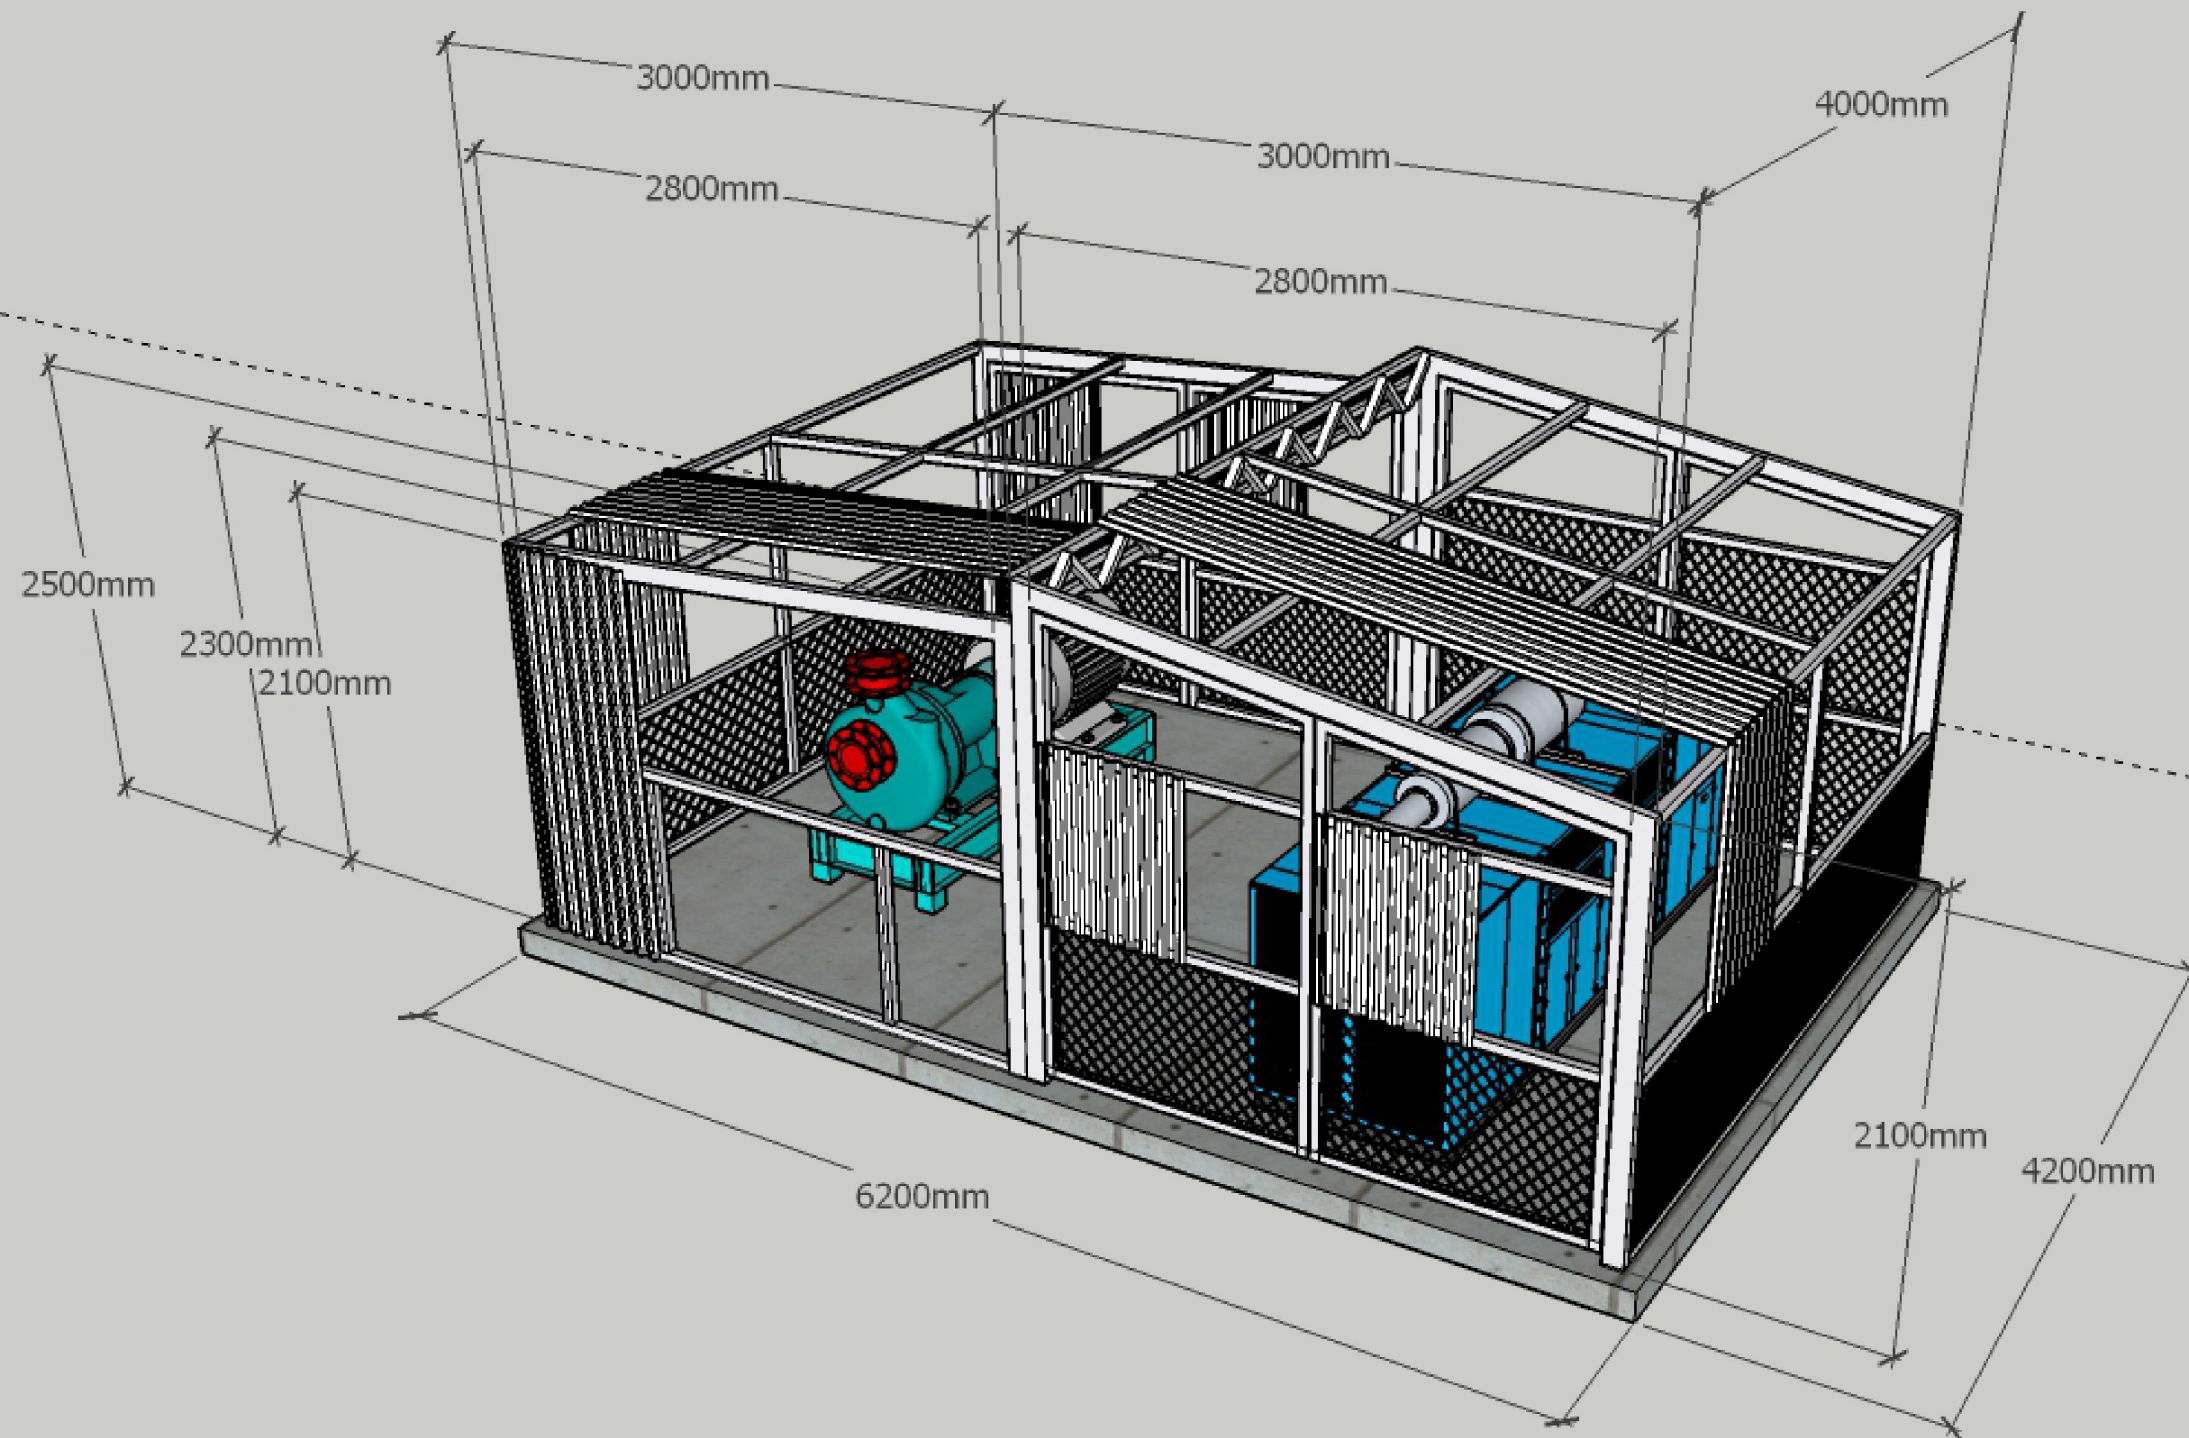
Comments:
Sheet 3 of 5
.
.

Plan:
Shed showing pump
North west Elevation

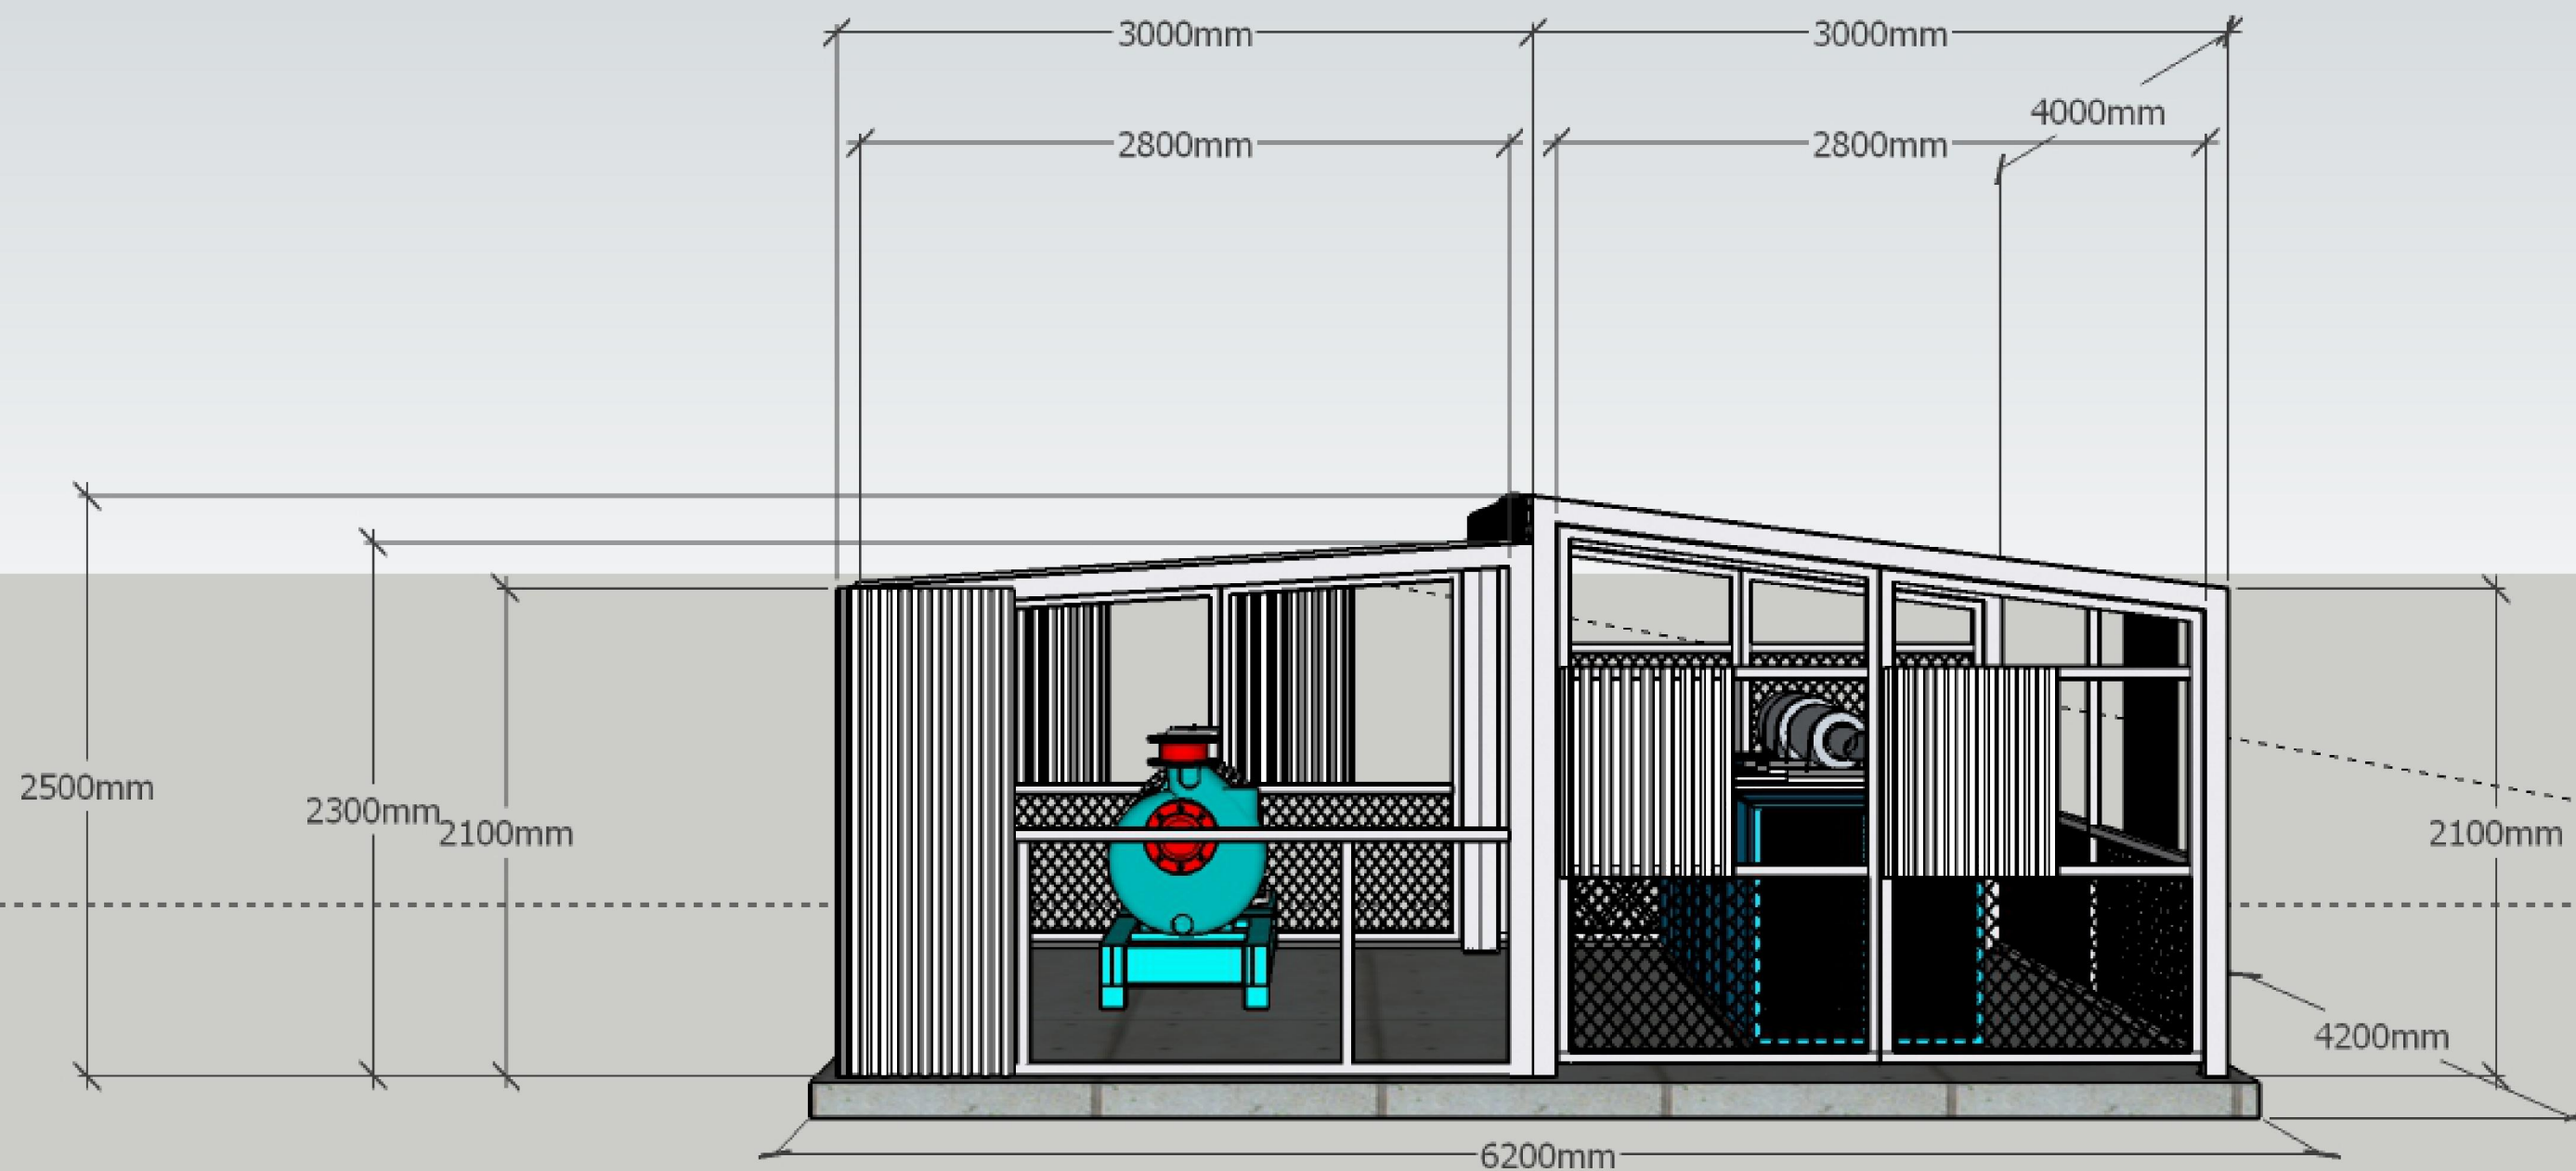
Sheet 4 of 5

Plan:
Shed showing pump
North Elevation

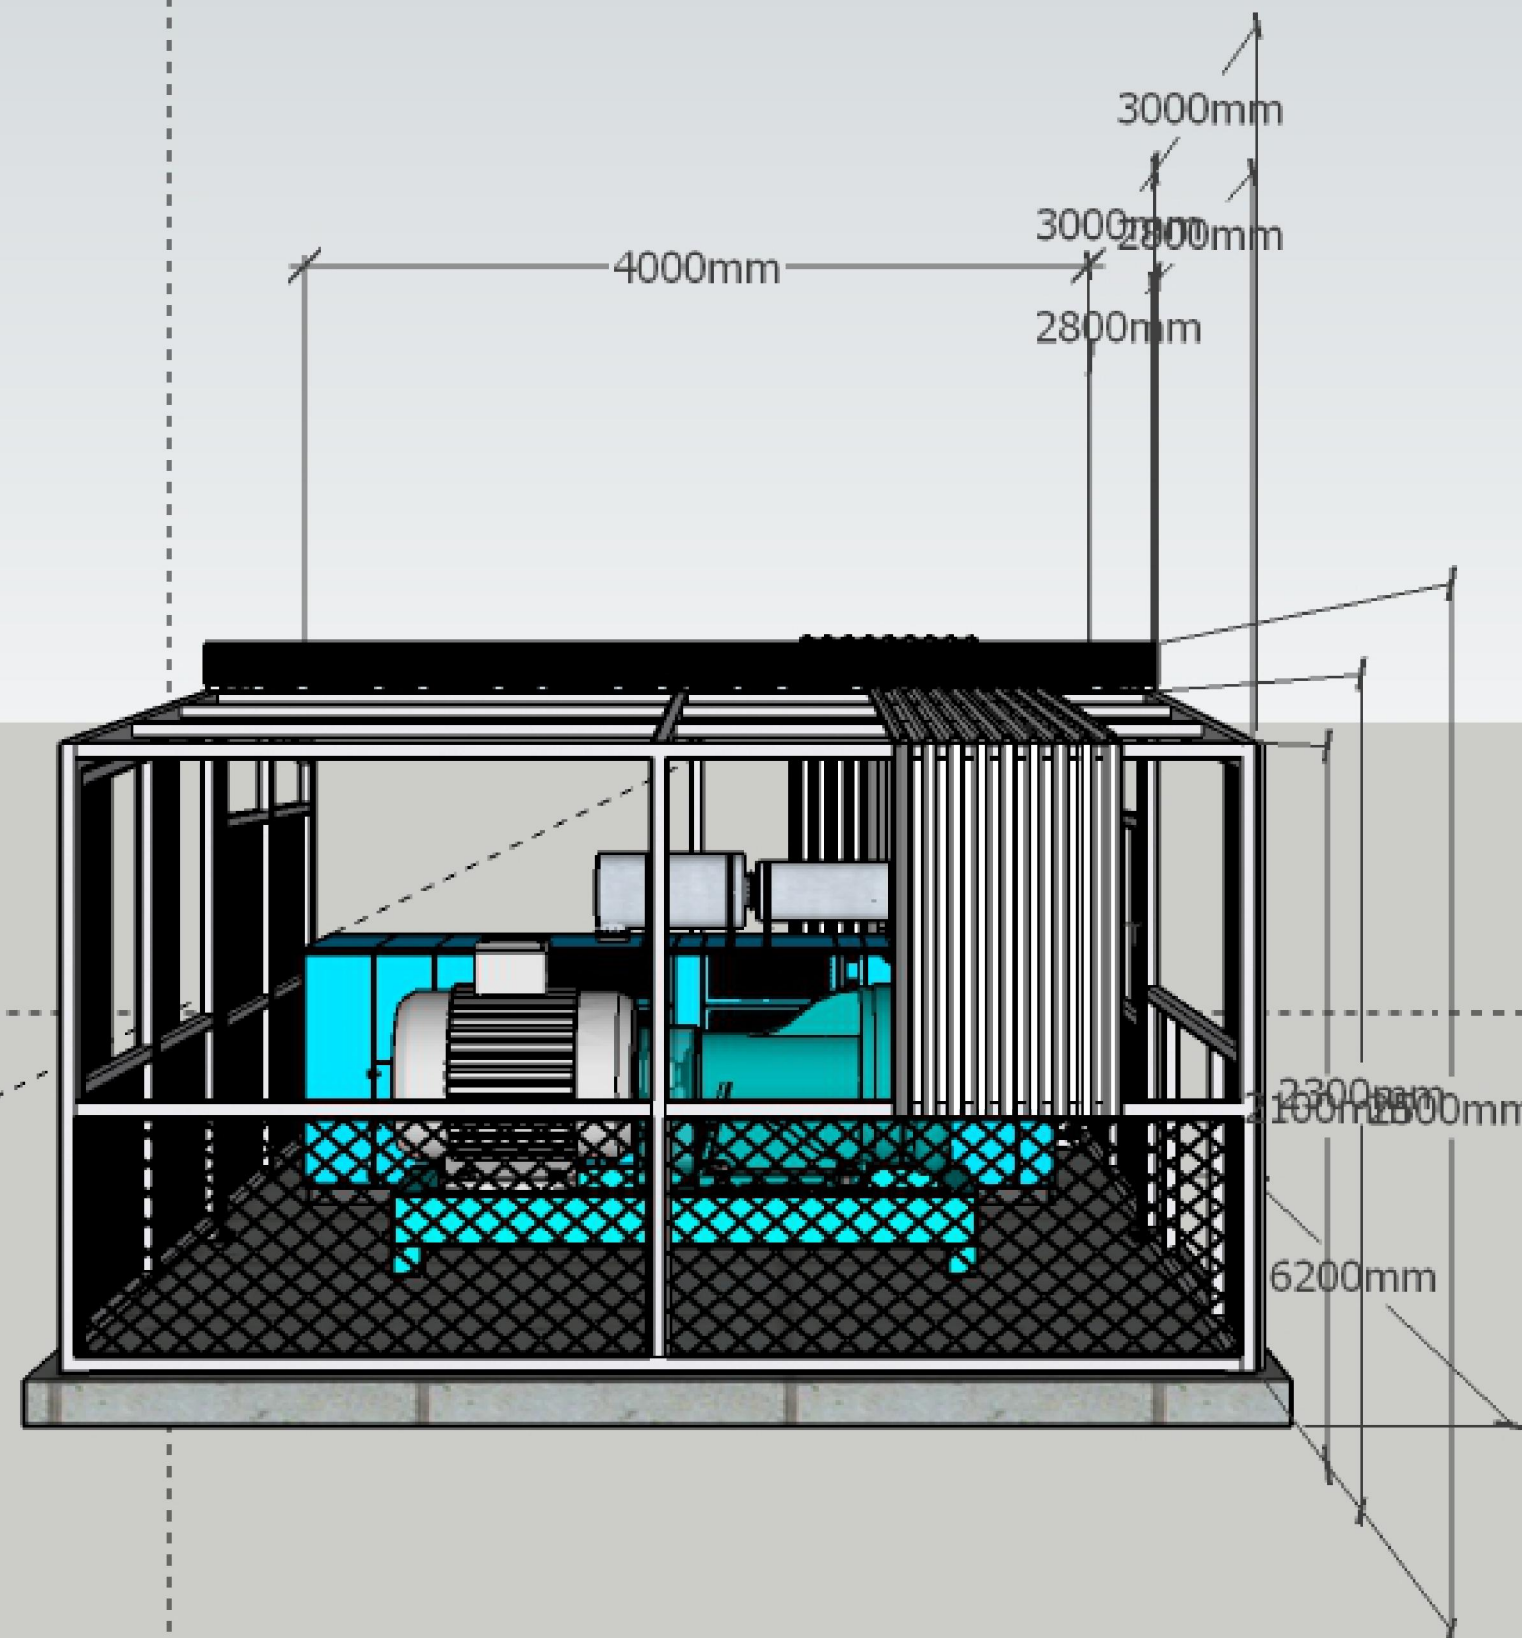
Sheet 5 of 5

Shed showing pump

East Elevation

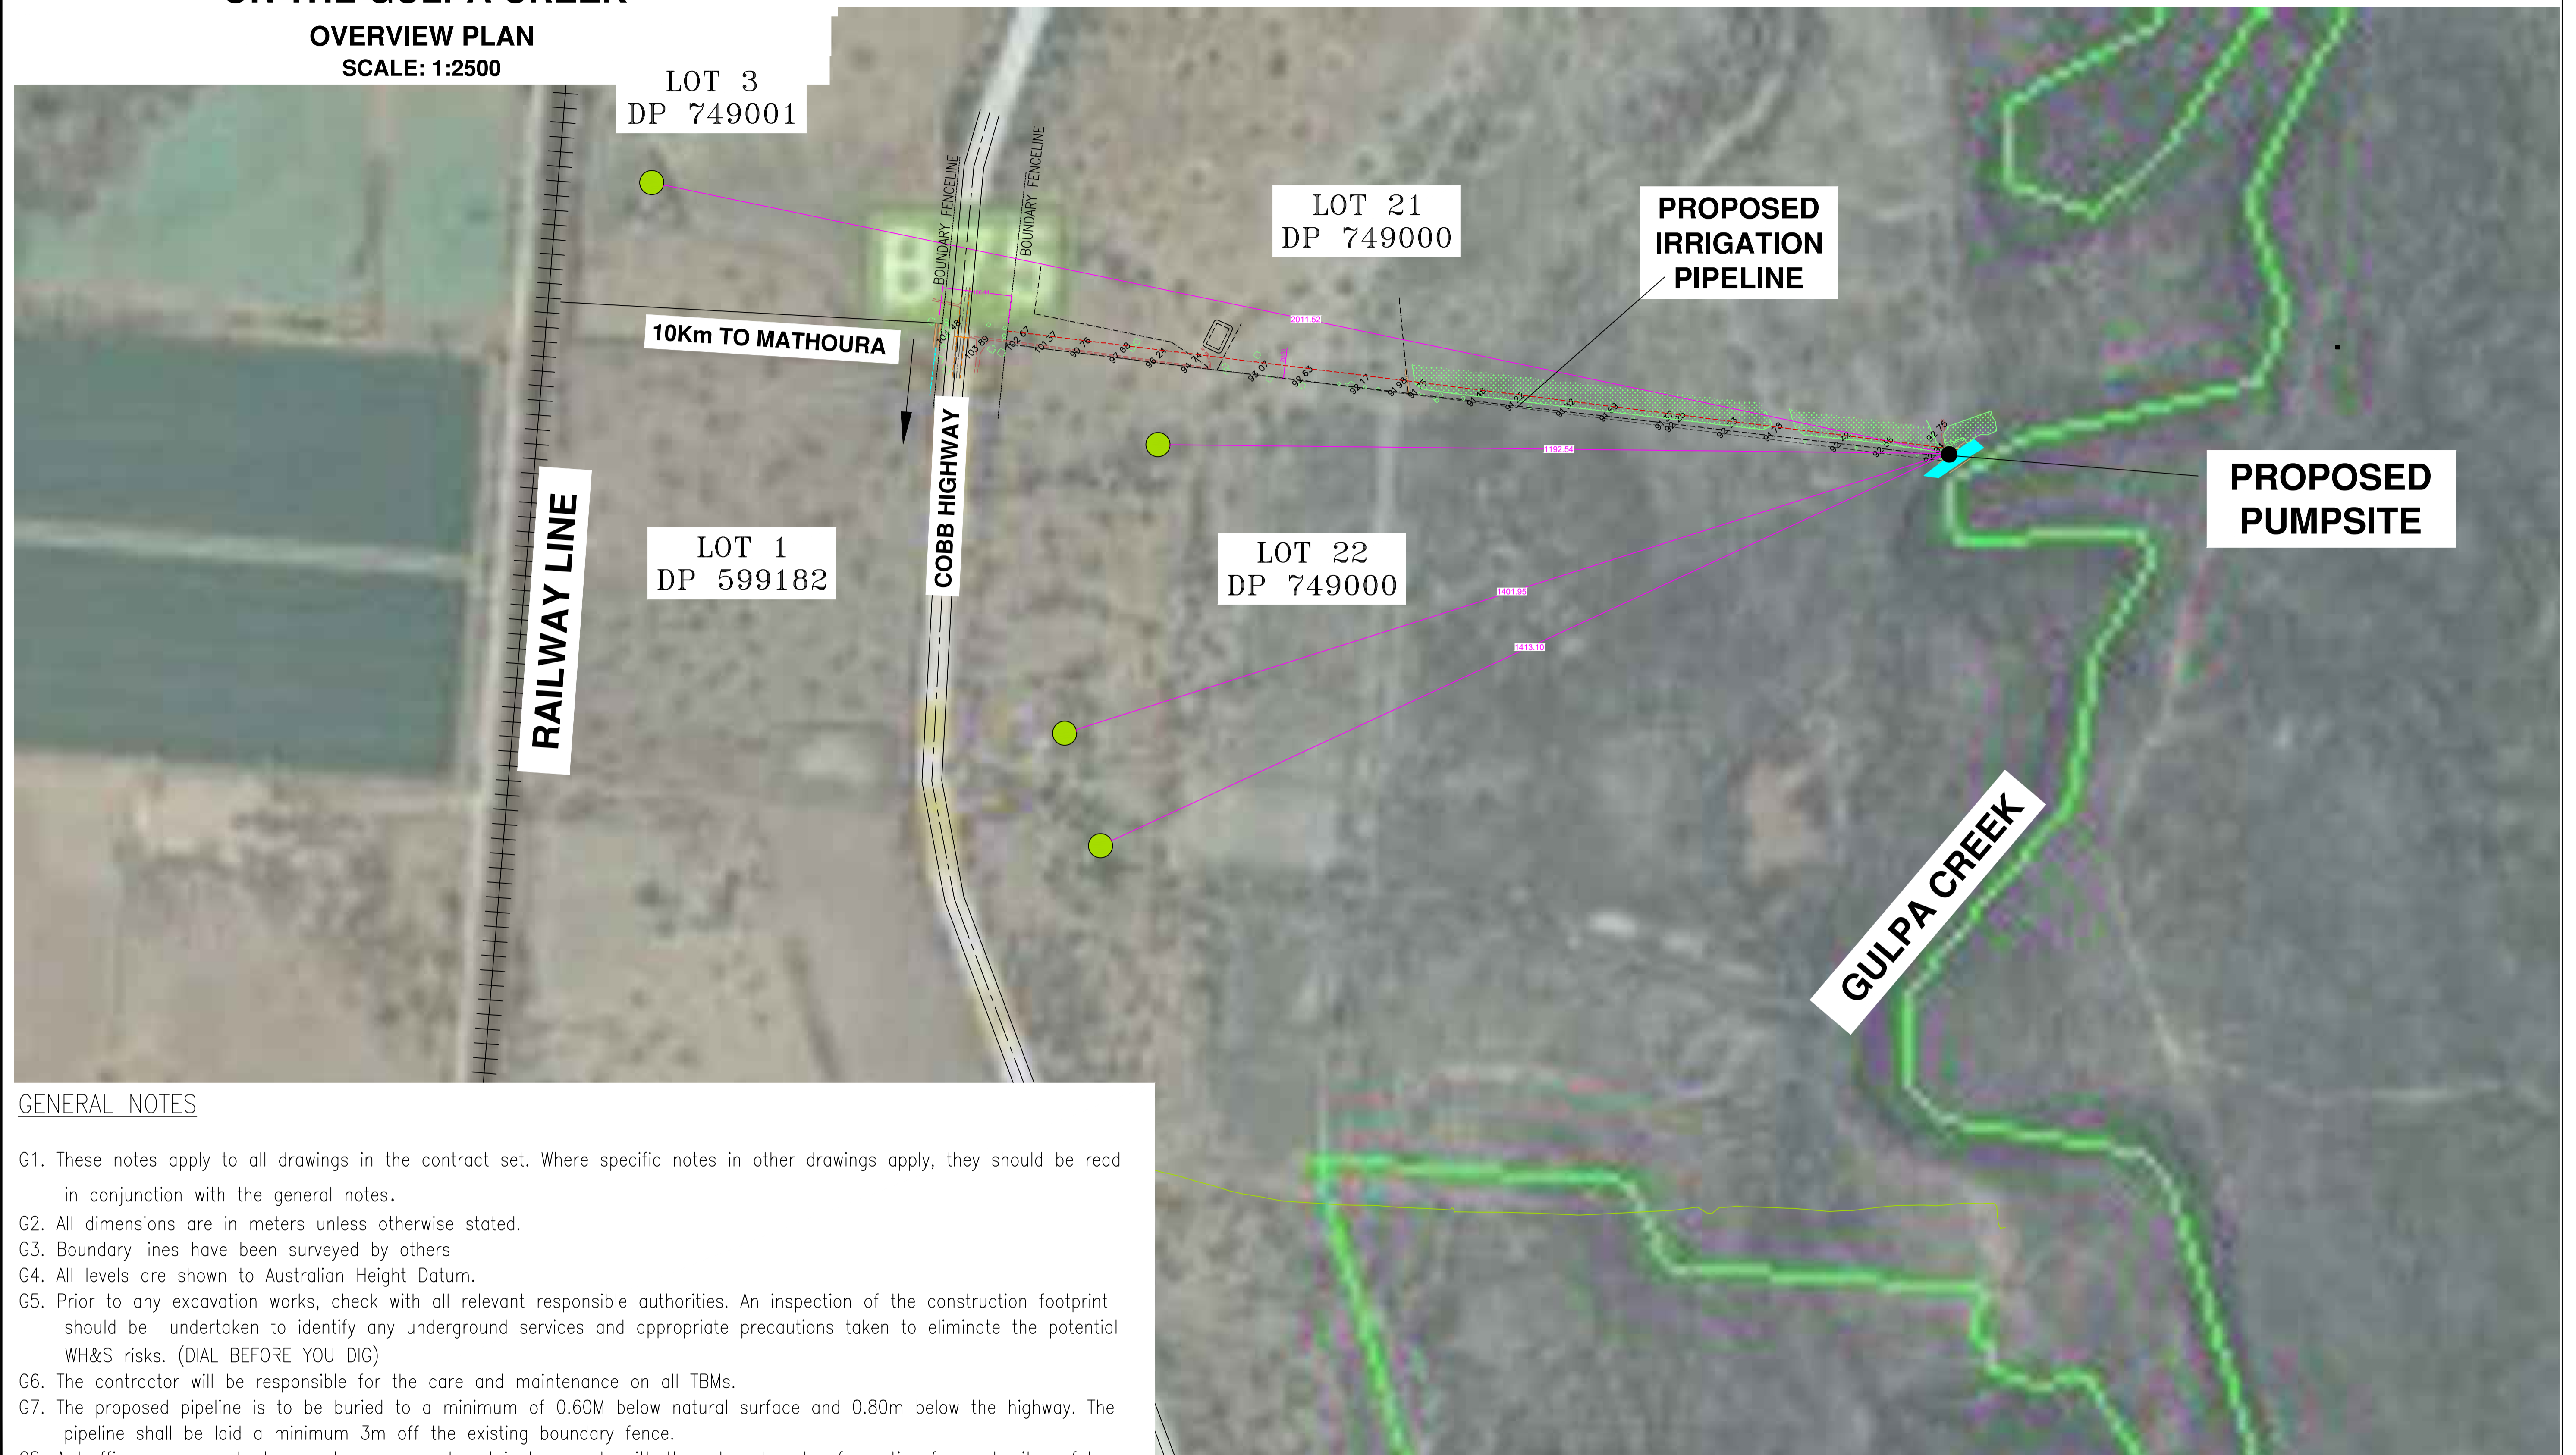
OVERVIEW PLAN
SCALE: 1:2500

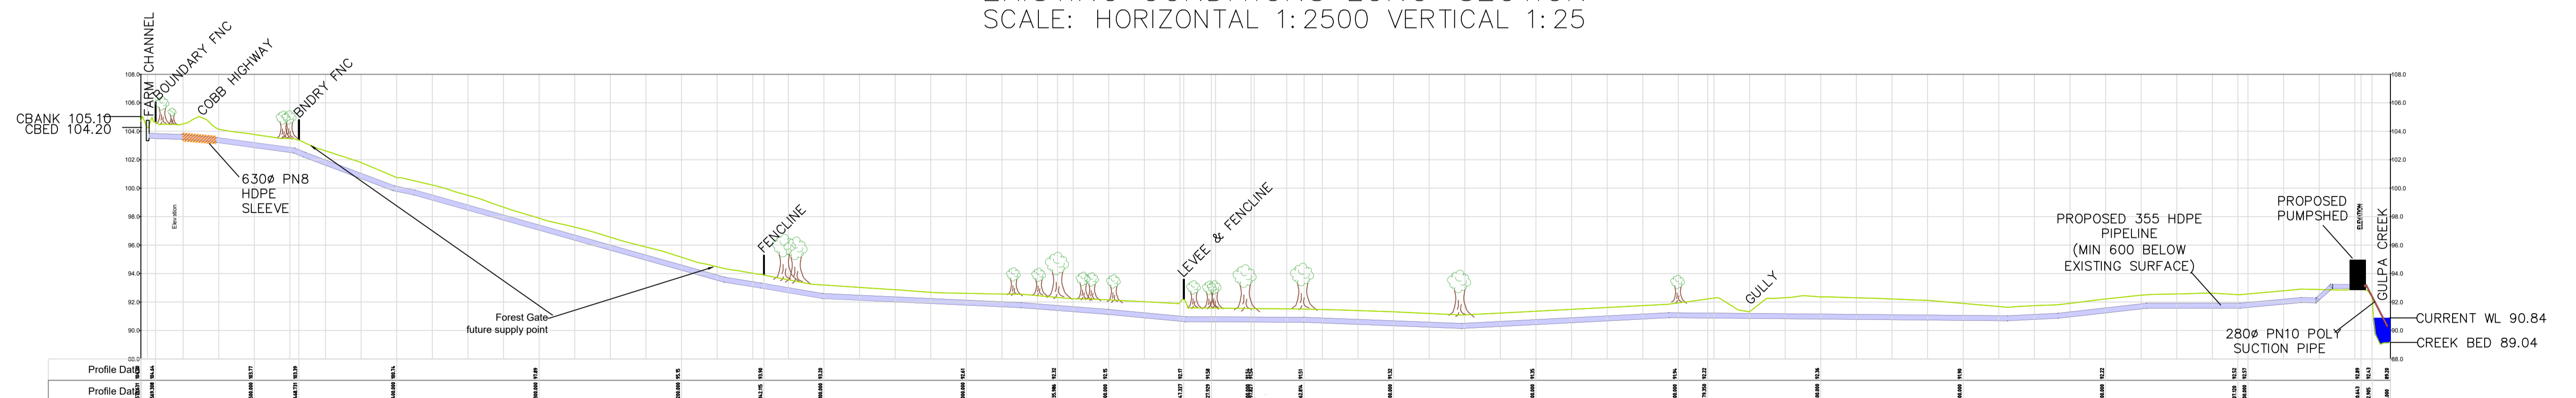
EXISTING CONDITIONS LONG-SECTION
SCALE: HORIZONTAL 1:2500 VERTICAL 1:25

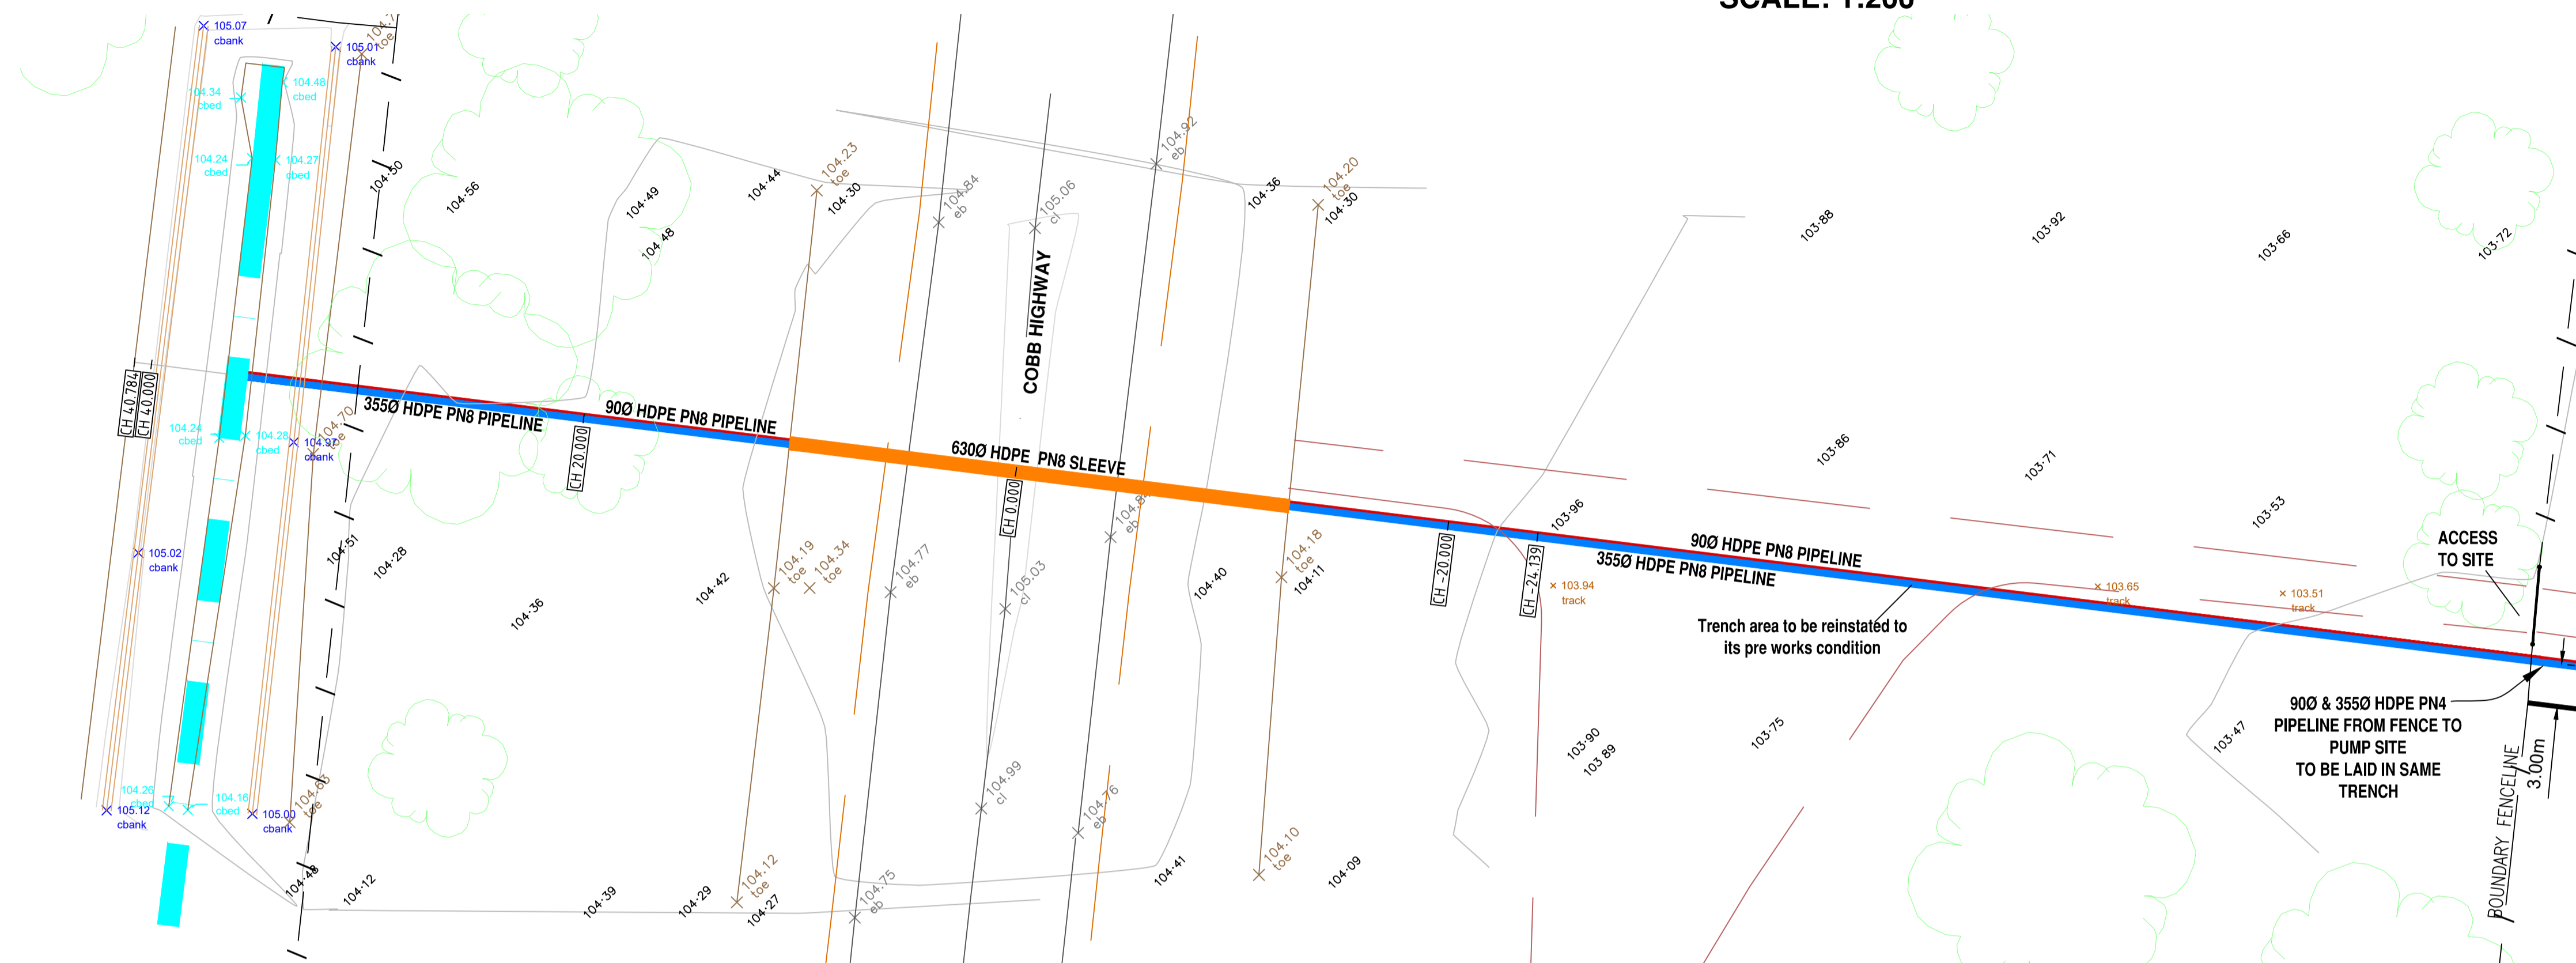
HIGHWAY CROSSING ENLARGMENT PLAN

SCALE: 1:200
