Project:
Maudesley Pump Supply Relocation
Client:
Maudsley Pty Ltd
Address:
'Forest Gate'
Cobb Hwy Mathoura, NSW

PROPOSED IRRIGATION PUMP AND PIPELINE ON THE GULPA CREEK

Cultural Heritage Due Diligence Assessment

New pump site and pipeline on the Gulpa Creek and Cobb Hwy at
'Forest Gate', Gulpa NSW

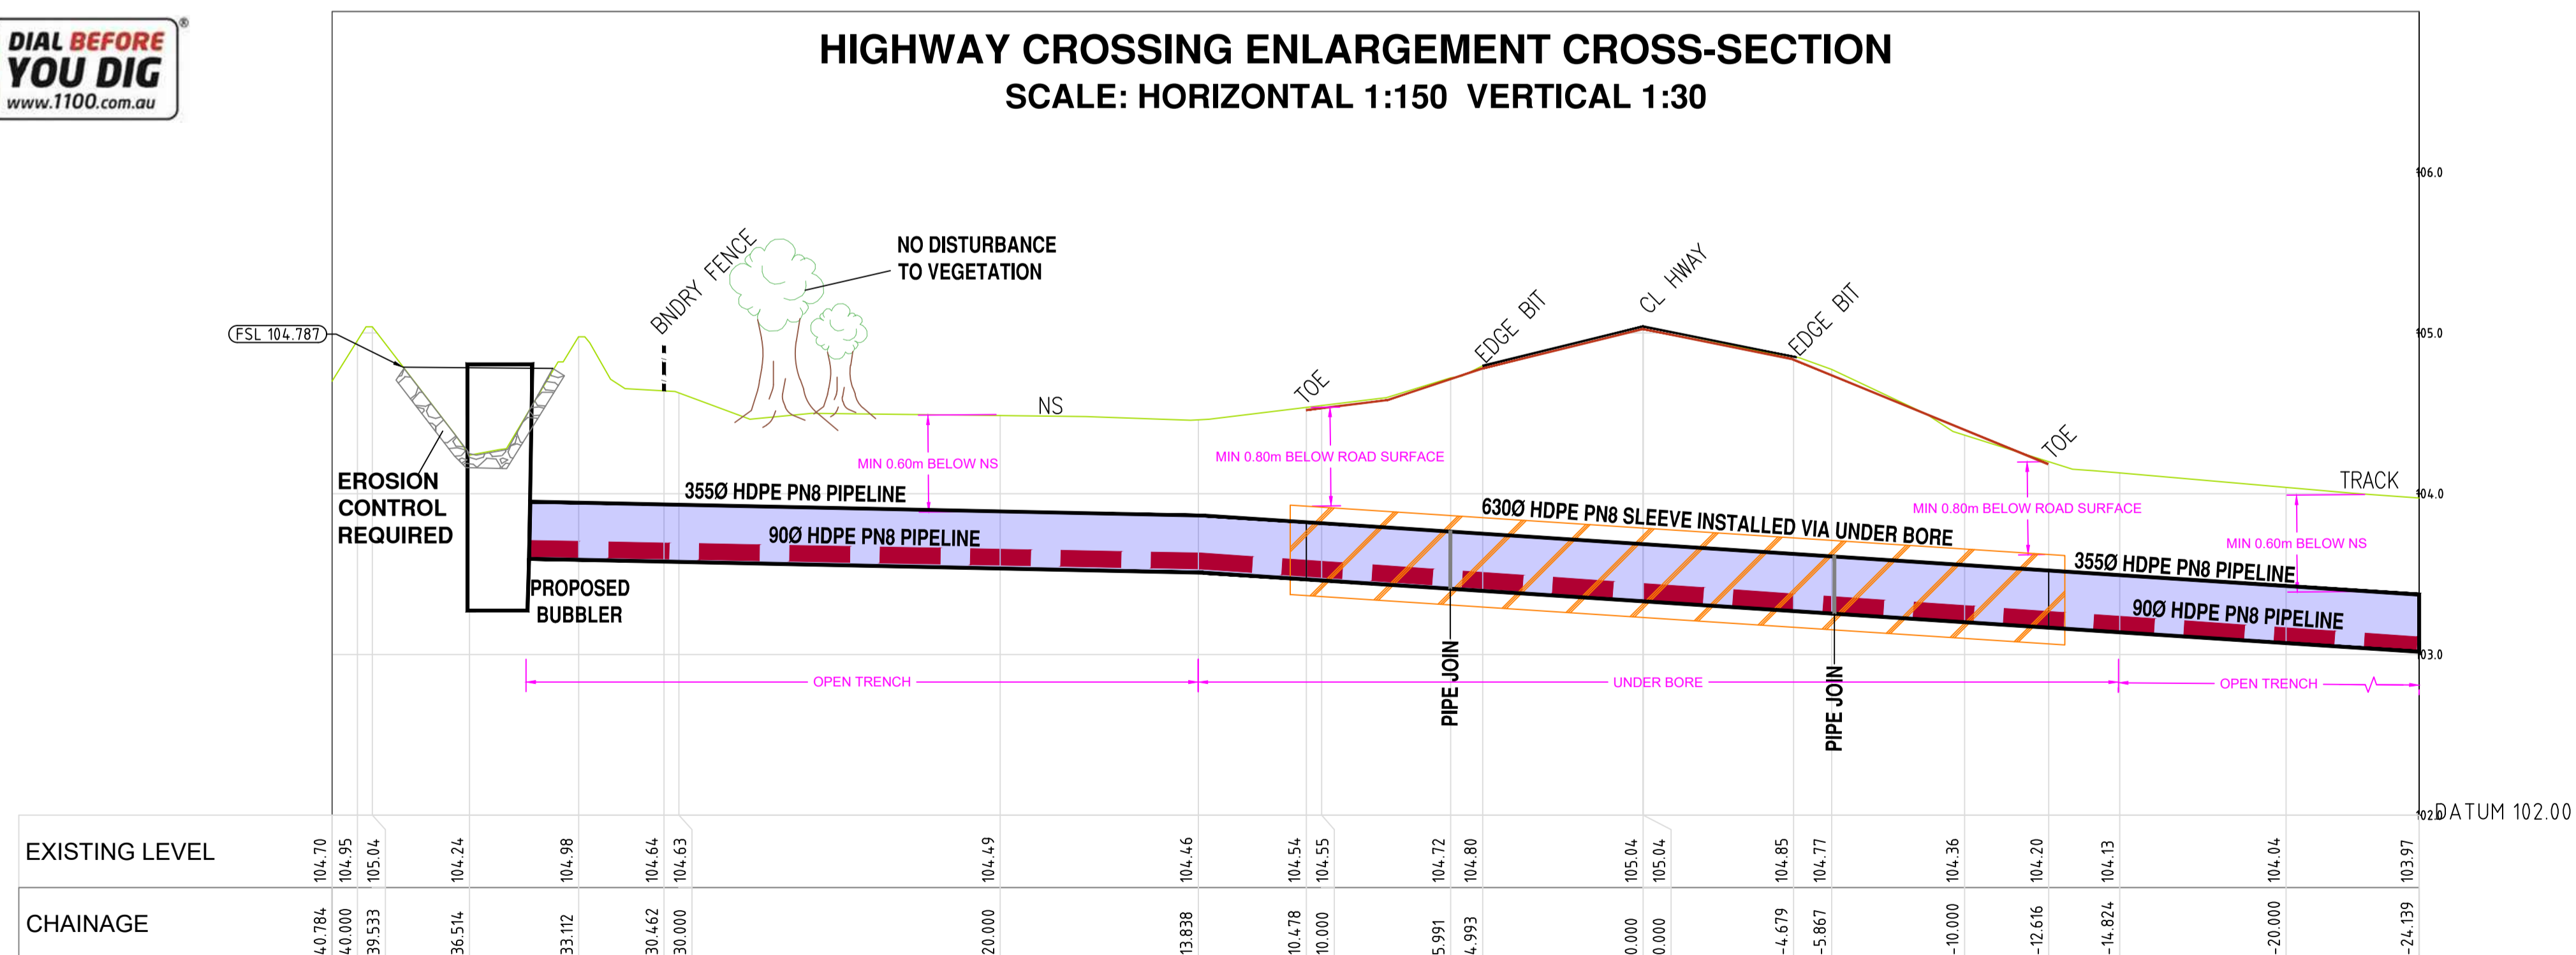
HIGHWAY CROSSING ENLARGEMENT CROSS-SECTION

SCALE: HORIZONTAL 1:150 VERTICAL 1:30

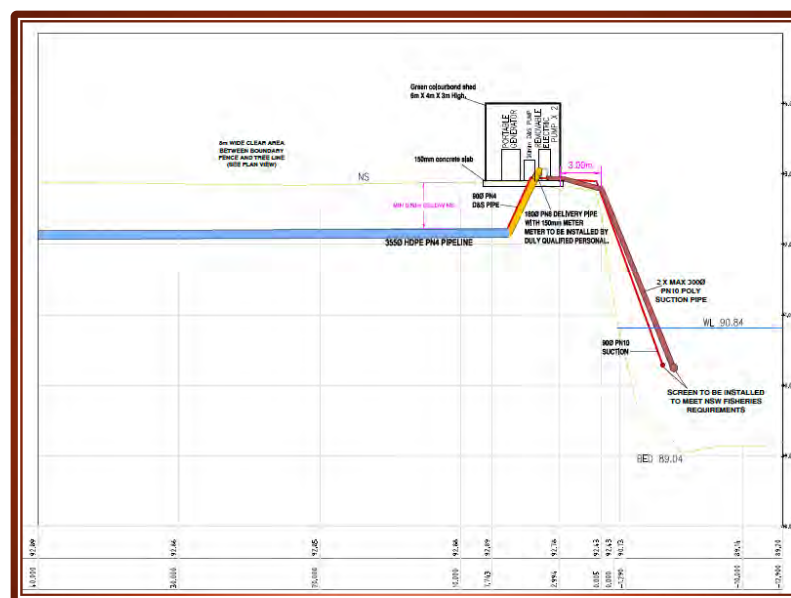
Figure 3-3 - Image showing cross section of project pump site (Source Rich River Irrigation Developments Plans)

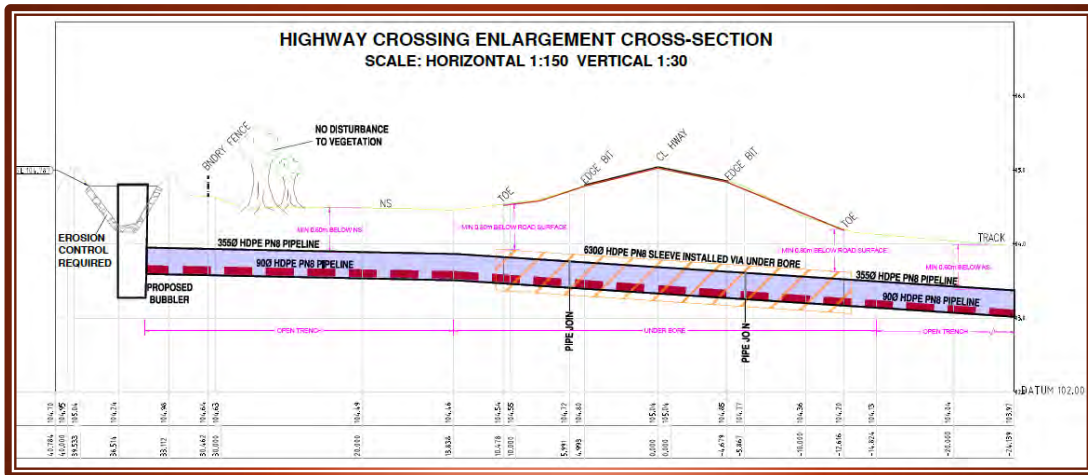
Figure 3-4 - Image showing cross section of project Cobb Highway crossing (Source Rich River Irrigation Developments Plans)

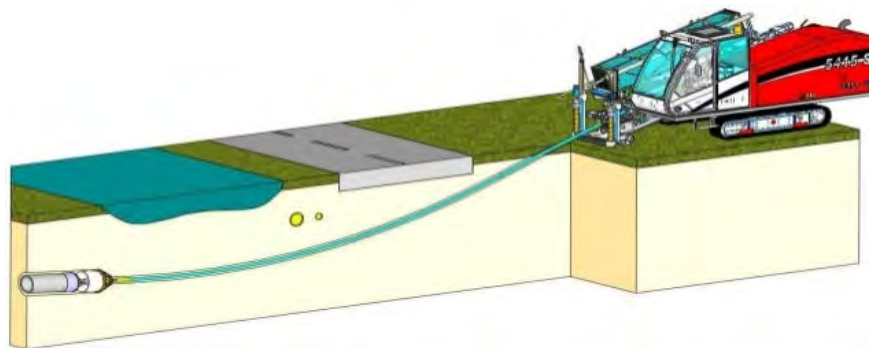
The construction methodology of utilising horizontal under boring for pipeline installation beneath the Cobb highway is diagrammatically shown below. The benefits of utilising this installation methodology is as can be seen below, there is minimal disturbance of the ground surface and no vegetation is required to be removed as part of the project works.

Figure 3-5 – diagram showing the construction method of Horizontal boring.

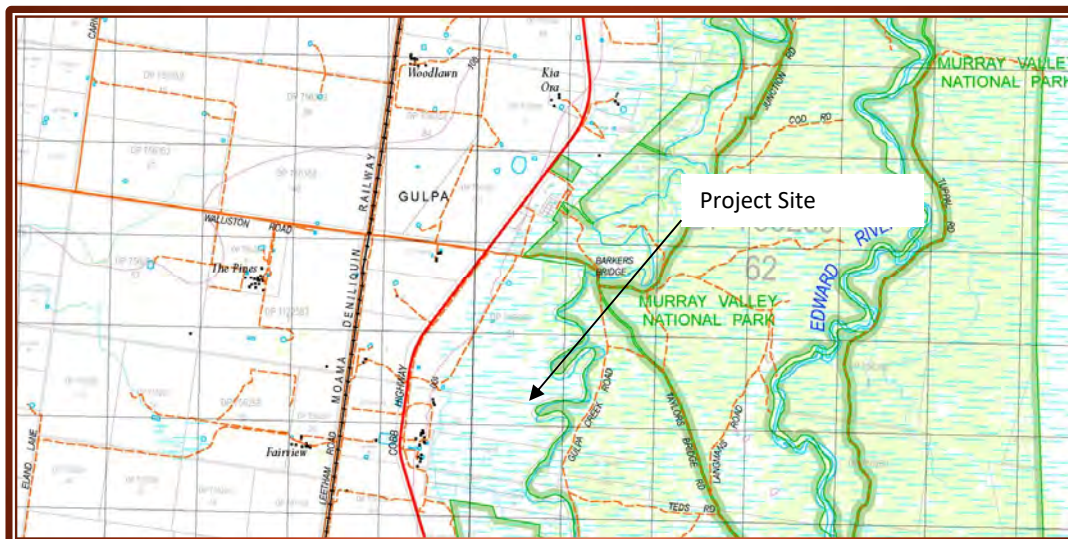
Figure 3-10 - Image showing topography of the project site. (Source Six maps)

The general trend of slopes from the top of the Cadell Tilt within the district is to the west at approximately 1:10,000 (10cm/km or 0.01%). The area at the bottom of the Cadell Tilt slopes generally gently towards the Gulpa Creek and internal property lagoon system. This pump site has a natural surface elevation of 92.89m AHD at the top of bank and the Cobb Hwy road crossing has a natural surface elevation of 104.20 at road centreline.
